# A New Method for Monitoring Gears Surface Failures Using Enhanced Image Registration Approach

Ahmed Onsy and Mohamed Fouad  
MTC

## ABSTRACT

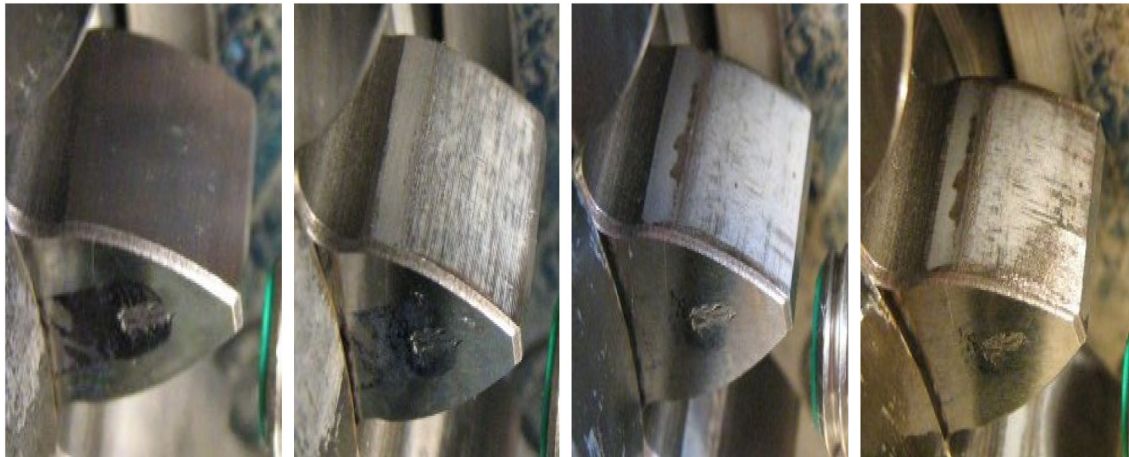
Observations of the progression of micro-pitting on a specific tooth flank of each gear were carried out by capturing an image every  $8 \times 10^6$  cycles for both test pinion and wheel gear flanks (marked tooth (no. 1)), and these images were taken as a record showing the progression of damage as a result of continuous running at relatively high torque / contact stress. Figures 3 and 4 show photographs of test gears taken at the beginning of test, and after completion of running at 210Nm, 310Nm and 350Nm respectively, and the gear damage observed during inspection is shown in Table 1.

Figure 3. Pinion flanks showing: (a) Before gear test (b) Micro-pitting after testing at 210 Nm ( $13.7 \times 10^6$  cycles) (c) Micro-pitting after testing at 310 Nm ( $75.76 \times 10^6$  cycles) (d) Micro-pitting, small-scale macro pitting and scuffing after testing at 350 Nm ( $75.78 \times 10^6$  cycles)

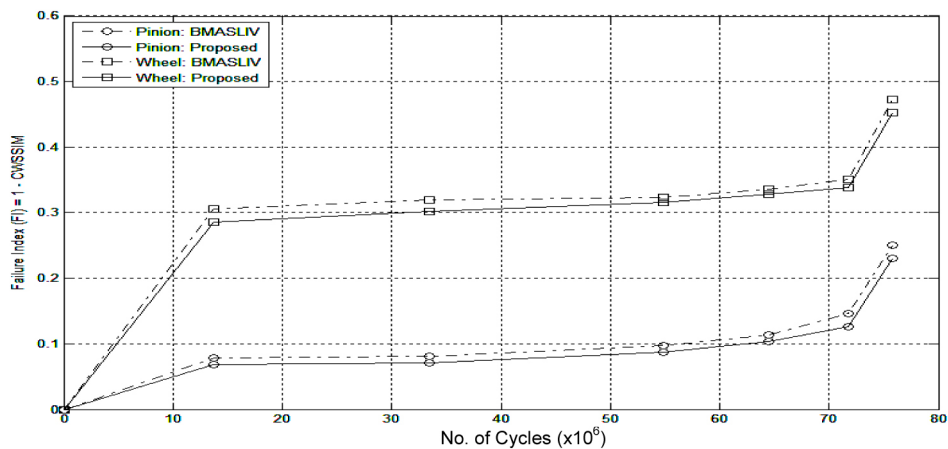
A Matlab algorithm has been developed to apply the image registration approach used in this paper and to then compute the FI, shown in (2), using an array of images as shown in Figures 4 and 5. The algorithm computed the FI at  $13.7 \times 10^6$  cycles for the pinion gear of 0.08 while for the wheel gear of 0.16, which is higher than the pinion FI value. Also, at  $75.78 \times 10^6$  cycles the FI value for the pinion is 0.25 while for the wheel is 0.35, which is again higher than the pinion FI value. Figure 5 illustrates the FI versus number of cycles, showing that the micro-pitting progressed gradually during the testing period using the proposed approach is more closer to the vibration and oil debris analysis results, compared to that of the BMASLIV approach [11] that uses the IR approach in [7]. The FI results are confirmed by the gear metrology results as shown in Figures 6 and 7.

Figure 5. Failure Index (FI) values for both pinion and wheel over test period

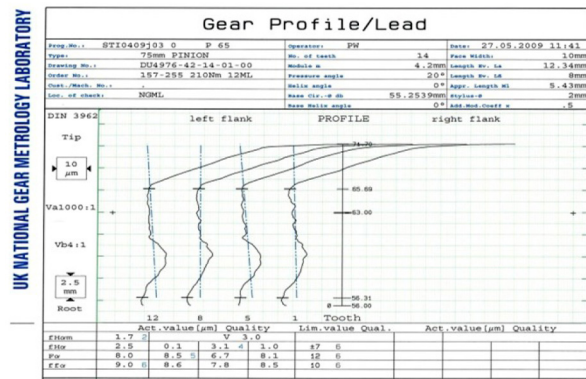
It is evident that the flanks of the test gears scuffed significantly as a result of surface fatigue during continuous running at relatively high torque/contact stress. To quantify the damage on the gear flanks, profile deviation was measured on 4 teeth per gear using a gear measuring machine. The records of gear profile measurements at the end of stage 1 of the test and at the end of stage 3 respectively are shown in Figures 6 and 7. The gear involute measurements confirm the results of the IR approach.

Figure 6(a). Pinion profiles of 4 teeth after test day 3. The maximum profile deviation caused by micro-pitting is evaluated as around 10 µm.

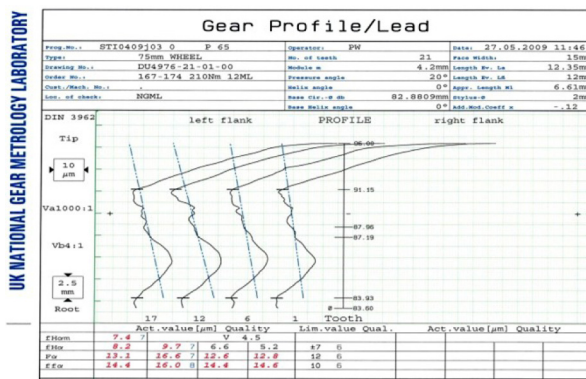
Figure 6(b). Wheel profiles of 4 teeth after test day 3. The maximum profile deviation caused by micro-pitting is evaluated as around 15 µm.

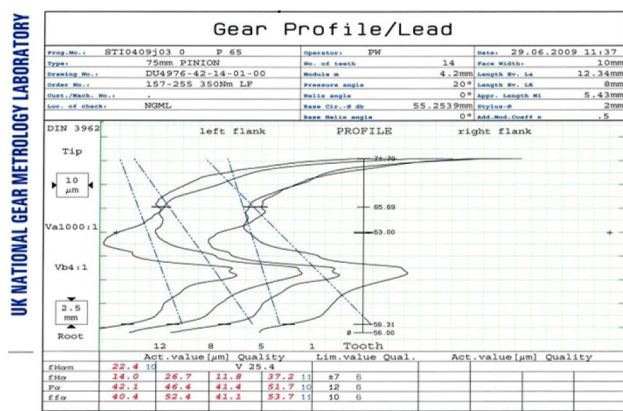
Figure 7(a). Pinion profiles of 4 teeth after test day 18. The maximum profile deviation caused by micro-pitting and macro pitting is evaluated as around 50 µm.

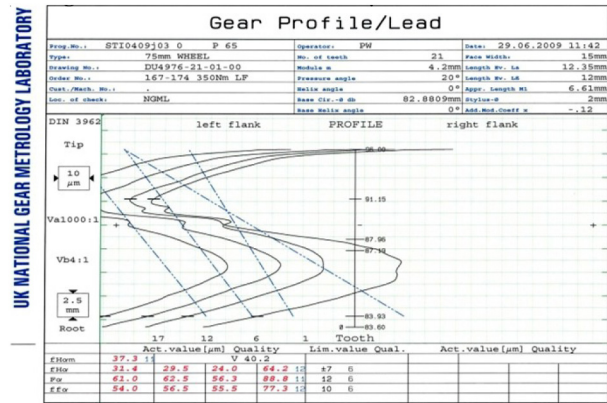
Figure 7(b). Wheel profiles of 4 teeth after test day 18. The maximum profile deviation caused by micro-pitting and macro pitting is evaluated as around 70 µm.
