Machinery transportation management: case study of "plant-trailer" H&S incidents

# Machinery transportation management: case study of “plant-trailer” H&S incidents

**Purpose** – The purpose of this paper is to investigate causal agents of health and safety (H&S) incidents among “plant-trailers” (as used by construction and utility contractors to transport mechanical machinery); including the relationship(s) of such incidents to routine safety inspections and, plant maintenance functions.

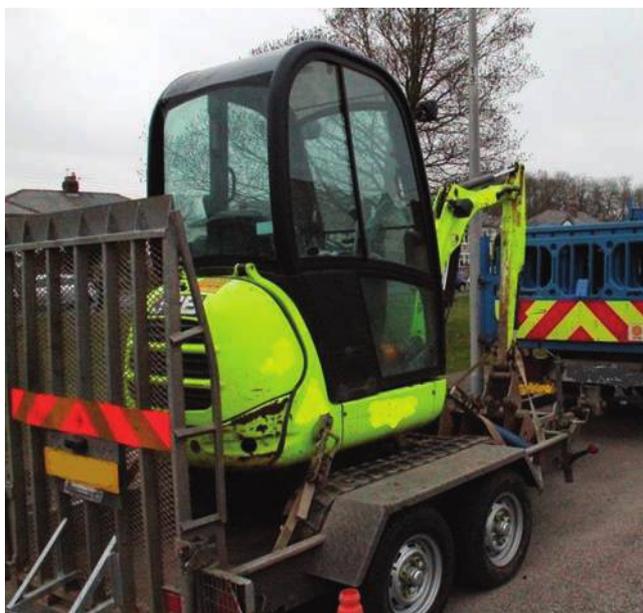
**Plate 1.**  
Typical plant-trailer  
configuration (twin axle)

A particular plant item commonplace within the construction and utility sectors is the “lightweight” trailer – generally referred to in the workplace as a “plant-trailer” (hence, this description is used hereafter for consistency). There are various types (e.g. single or double axle) and configurations of plant-trailer available and often, these are used to transport smaller plant items such as mini-excavators or pedestrian compaction rollers[1]. A typical plant-trailer loaded with a mini-excavator in its towing configuration, is shown in Plate 1. The popularity of these trailers stems mainly from the fact that (within the UK), they can be towed behind a lorry or commercial vehicle on a “standard” driving licence and therefore, help contractors save costs that would otherwise be incurred using larger, or specialist transportation equipment such as a “low-loader”[2].

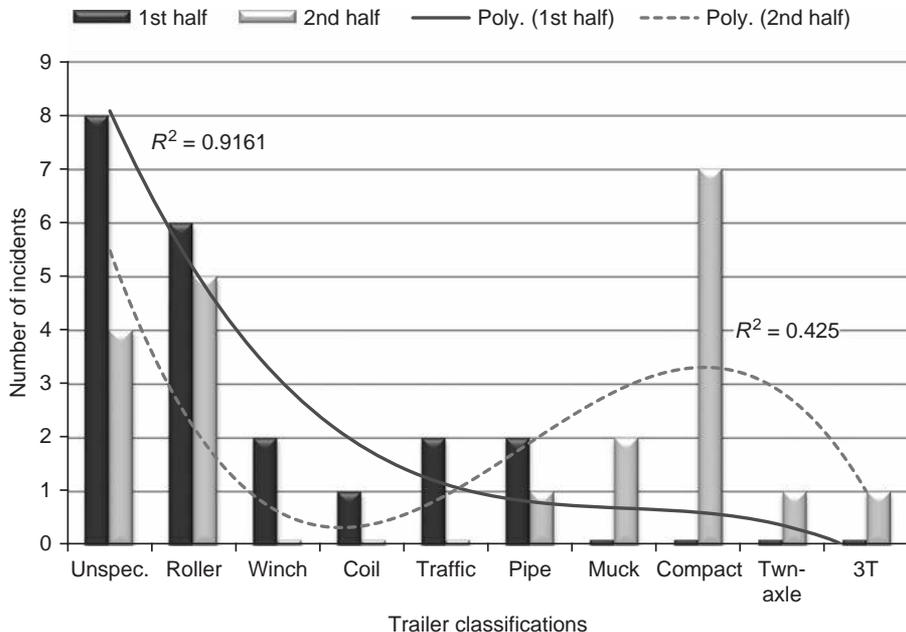
**Figure 3.**  
Incidents per halves of chronological data set

second “time halves” of the data set. Time halves were defined by listing all 42 incidents chronologically and dividing this into two equal sub-samples ( $n = 21$ ). This method of sub-sample composition was employed because of time-skewness among data (refer Table II). That is, if data were delineated by equal first- and second-half time periods, the 2009-2012 sub-sample ( $n = 33$ ) was biased, because there were many fewer incidents ( $n = 9$ ) reported during 2005-2008.

Greater frequency of incidents in the second-half period (Figure 3) suggests either a declining H&S situation (but this needs to be reconciled with any growth in fleet size to assess a worsening or improving situation); and/or more rigid incident reporting. Possibly linked to the last proposition, it is noted that the unspecified group declined in number; which too could mirror more accurate reporting procedures (of late). Incidents among classifications increased in the latter period for: muck trailer, compact excavator trailer, twin axle trailer and 3T trailer; simply because no incidents for these machinery types were reported in the first period. The most marked increase was for compact excavator trailers, perhaps being synonymous with increased usage of compact excavators (especially on utility works) since mid-1990 (Holt and Edwards, 2012). Order three polynomial trend lines[5] show a first period downward trend; and a spike from said excavator trailer incidents (causing the low  $R^2$  value = 0.42) in the second period.

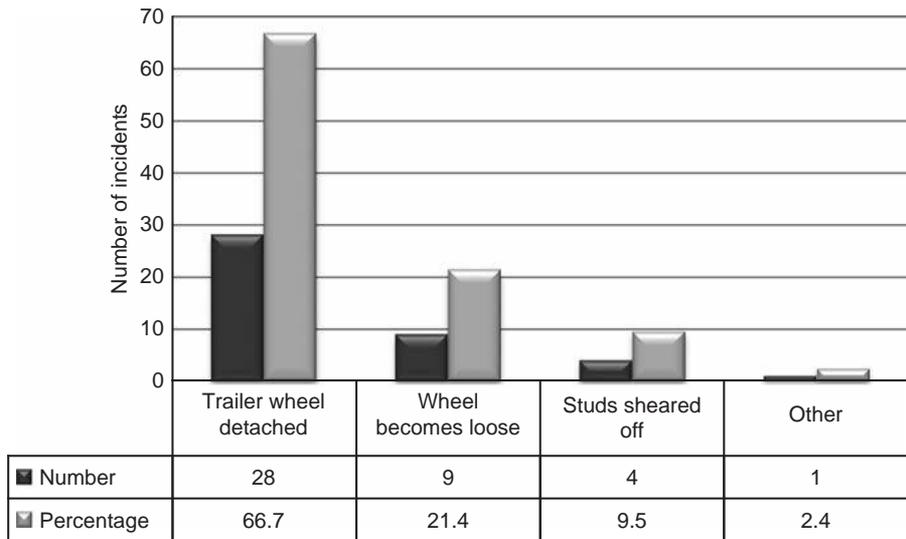
**Figure 4.**  
Types of incident  
among all data

Types of incident are summarised in Figure 4. Wheel detachment (“while traveling” given the previous analysis) is the main incident type (28 cases, 67 per cent). These statistics may vary slightly because “studs sheared off” and “other” did not specify whether this led to wheel detachment or wheel loosening. These incident types are analysed in more detail later.

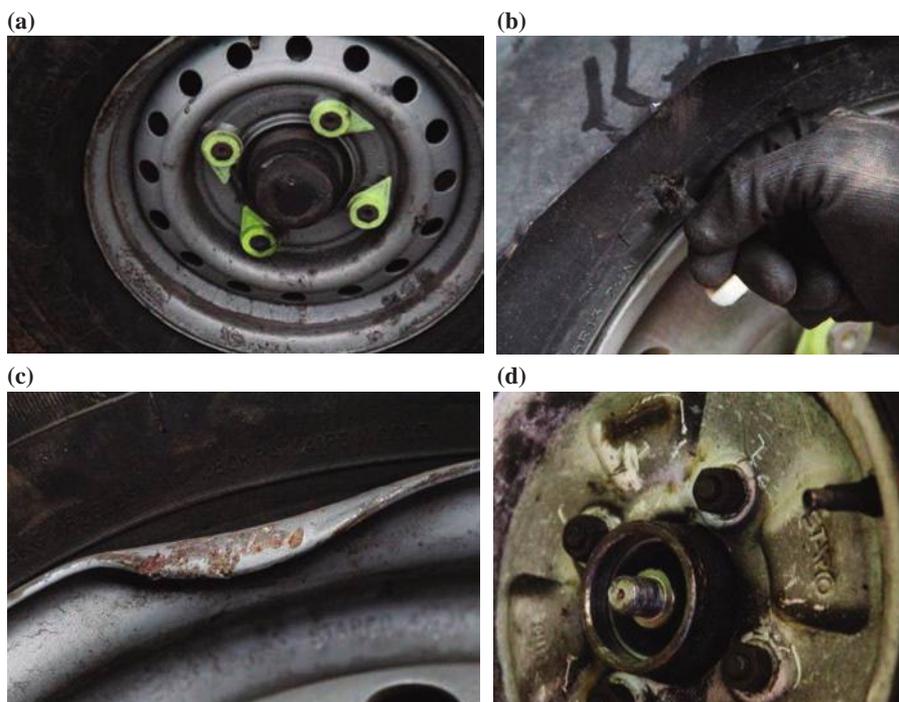
**Plate 2.**  
Aspects of plant-trailer  
inspection

**Notes:** (a) Wheel stud indicators misaligned (loose studs). Note also valve cap missing (poor inspection/maintenance); (b) tyre wall damage (could be driver abuse from kerbing); (c) wheel rim damage (could be driver abuse from kerbing); (d) bearing damage, hub cap missing, valve cap missing

Based on the distribution of faults observed, in addition to the more general aspects of trailer integrity and safety, inspection should particularly focus on wheel bearings (especially lubrication); correct torque and other tightening aspects of all wheel studs (such as need for lubrication to threads to achieve specified torque and the use of safety indicators); braking systems; and signs of any other trailer abuse or accidental damage. Plate 2 shows several aspects of inspection including the use of wheel stud indicators (here, non-aligned suggesting loose studs); and tyre, wheel and bearing damage.

- Routine and maintenance inspections should particularly focus on wheel bearings (especially lubrication); correct torque to wheel studs; the use of stud safety indicators; braking system check; and signs of any other trailer abuse or accidental damage.
