# Burning behaviour of rainscreen façades

Four reduced-height (5 m) BS 8414-1 façade flammability tests were conducted, three having mineral-filled aluminium composite material (ACM-A2) with polyisocyanurate (PIR) and phenolic (PF) foam and stone wool (SW) insulation, the fourth having polyethylene-filled ACM (ACM-PE) with PIR insulation. Each façade was constructed from a commercial façade engineer's design, and built by practising façade installers. The ACM-PE/PIR façade burnt so ferociously it was extinguished after 13.5 min, for safety. The three ACM-A2 cladding panels lost their structural integrity, and melted away from the test wall, whereupon around 40% of both the combustible PIR and PF insulation burnt and contributed to the fire spread. This demonstrates why all façade products must be non-combustible, not just the outer panels. For the three ACM-A2 tests, while the temperature in front of the cavity was independent of the insulation, the temperatures within it varied greatly, depending on the insulation. The system using PF/A2 allowed fire to break through to the cavity first, as seen by a sharp increase in temperature after 17 min. For PIR/A2, the temperature increase

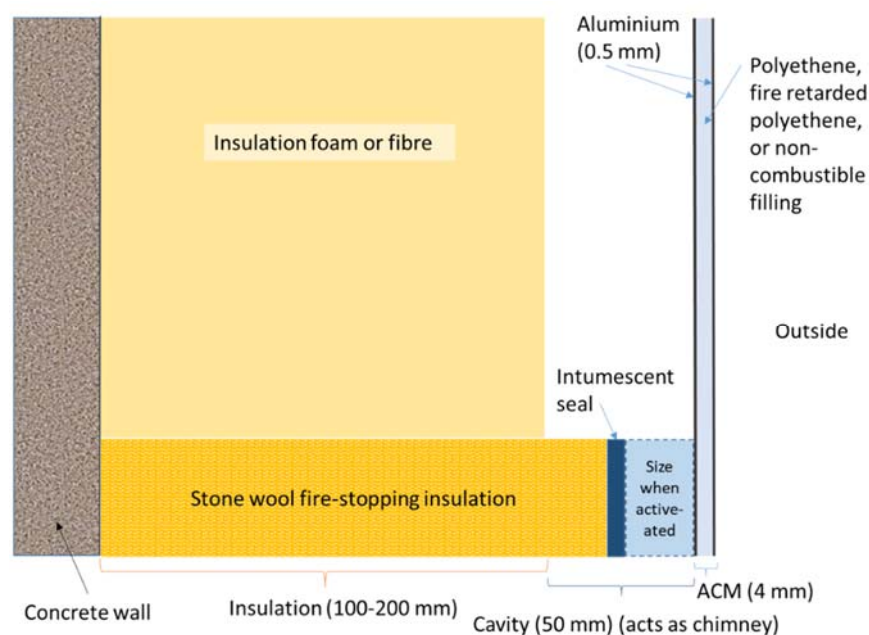
Figure 1 Typical ACM Rainscreen Façade Insulation system

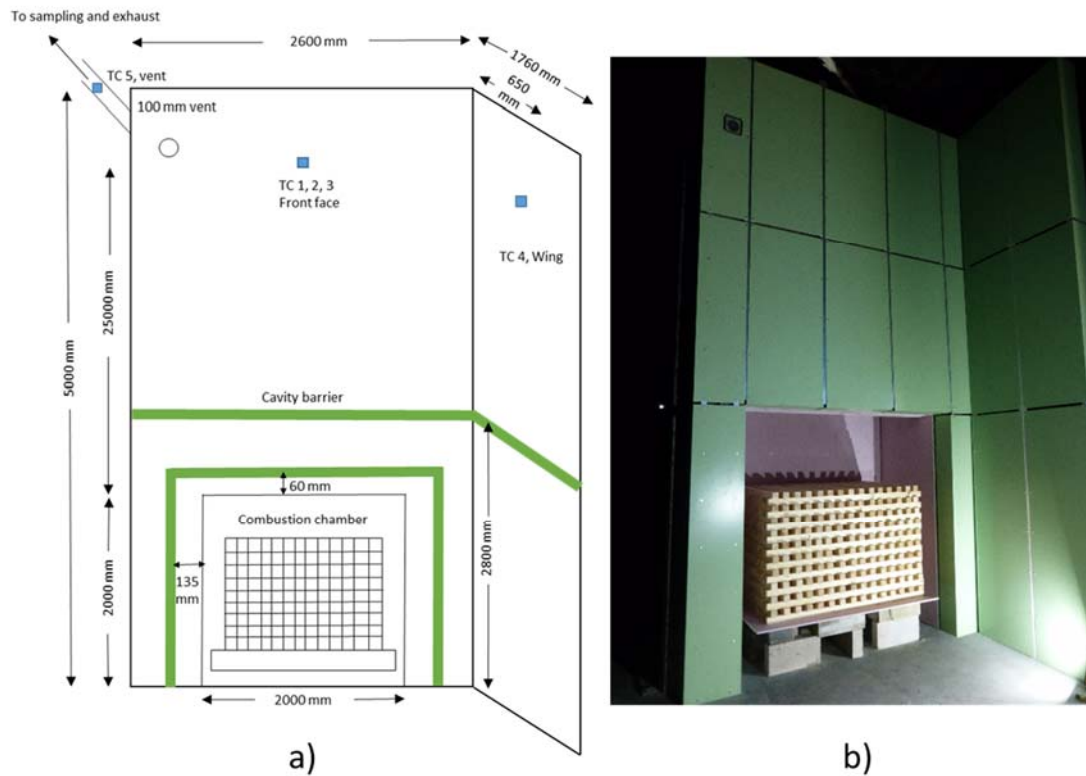
Each façade was built-up from the wall outwards as follows: a 100 mm layer of insulation (180 mm in the case of stone wool), a 50 mm cavity, and a 4 mm thick ACM panel, attached with screws to aluminium rails. Cavity barriers were installed according to the manufacturers' instructions, with a 25 mm gap to the inner face of the ACM cladding panels. Thermocouples were located 2.5 m above the top of the combustion chamber, in the centre of the front face and the wing, as specified in BS 8414 (level 1), at the following positions: TC1 and TC4 (50 mm in front of surface), TC2 (midpoint of cavity) and TC3 (midpoint of insulation). A diagram of the test wall including the cavity barrier and thermocouple locations, and a photograph of the assembled wall, can be seen in Figure 2.

Figure 2 a) Diagram of the test wall, showing cavity barrier (green) and thermocouple locations and b) photograph of completed wall

The thermocouple data recorded from TC1 (Figure 2 a), at the centre of the front face of the façade (Figure 6), 2.5 m above the top of the combustion chamber, and protruding 50 mm in front of the face of the ACM, show similar fire growth rates for the SW/A2 and PIR/A2 tests, with slightly faster growth rates for the PF/A2 and PIR/PE. This may result from differences in external wind speed and direction, entering the test room through the 2 m<sup>2</sup> ground level opening, or the inherent irreproducibility of the BS 8414 wood crib fuel source. At 6 min into the test, the ACM-PE became involved in the fire and the temperature of the PIR/PE test exceeded that of the PF/A2 test. The drop in temperature of the PF/A2 around 18 min probably results from physical movement of the insulation slab to shield the thermocouple (Figure 8).

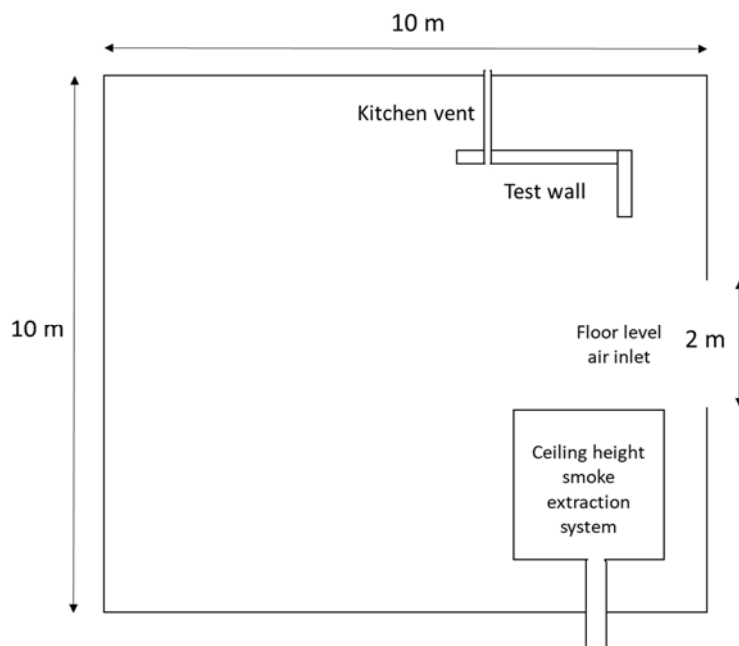
The ceiling of the test room was fitted with a 2.5 m x 2.5 m pumped extraction system for removal of smoke and exhaust gases. Sampling lines were installed within the extraction duct with probes used to measure the oxygen concentration, velocity and temperature of gases in order to calculate the heat release. An opening of 2 m<sup>2</sup> at floor level allowed air ingress as shown in Figure 3.

Figure 3 Plan view of the test room

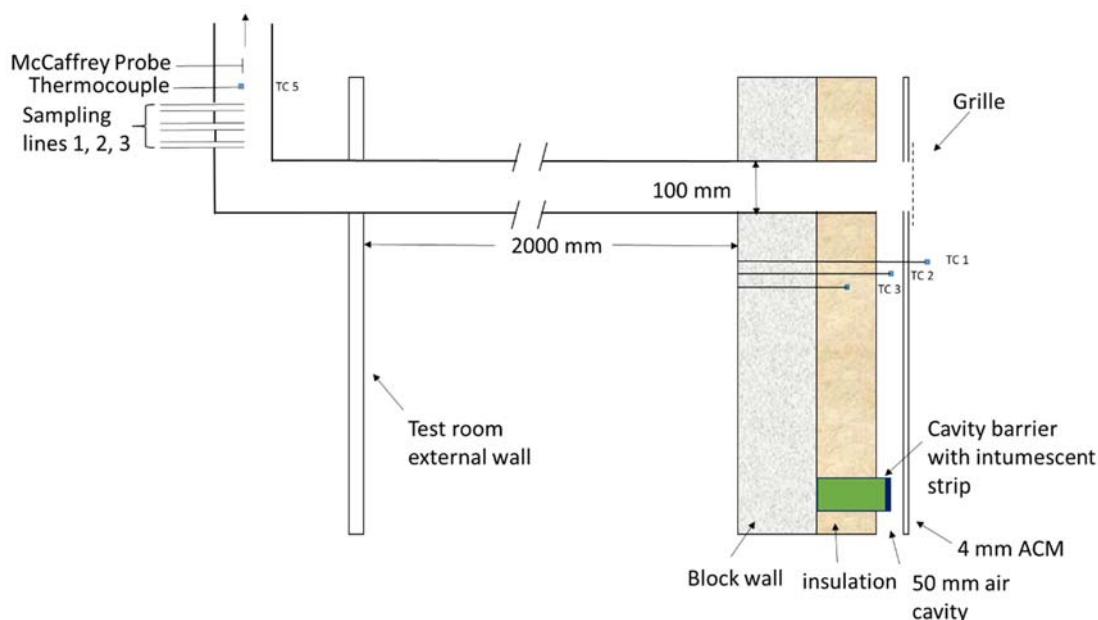
A 'kitchen vent' was included in the installation, since they are a common feature of modern building facades, but there is no requirement to include them in the BS 8414 test. The vent consisted of a 100 mm diameter galvanised steel pipe, which was flush with the front face of the insulation, and faced by a 150 mm x 150 mm steel grille on the outside of the ACM panel Figure 2 (b) and Figure 3. A thermocouple (TC5), a McCaffrey probe to measure flow, and gas sampling lines were added to the vent duct. A cross-section of the test wall, showing the position of the vent and thermocouples is shown in Figure 4.

Figure 4 Cross-section of the test wall and external vent

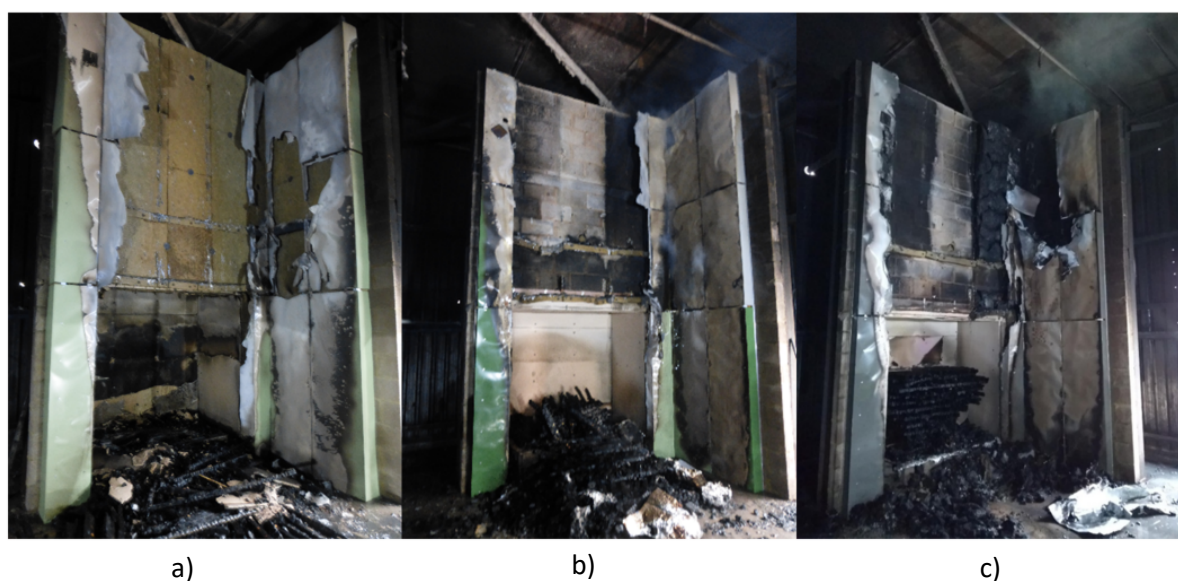
Figure 5 shows the test walls for the tests using ACM-A2 panels at the end of the test, after the wood crib was extinguished (30 min) and the fire allowed to continue for 60 min (from ignition).

Figure 5 Façade remains after the tests: a) SW/A2, b) PF/A2, c) PIR/A2

In all of the tests, some ACM panels, both A2 and PE, either melted, or burnt away from the wall and failed to protect the insulation from the burning wood crib. Aluminium melts at 660 °C, but loses strength around 500 °C. Many fires are significantly hotter than 660 °C, so it is unsurprising that the ACM panels, and the aluminium support rails, failed to maintain the structural integrity of the façade system. After this point, the insulation was exposed to the fire. For each of the three ACM-A2 tests, around 40% of the ACM has melted or fallen away from the test wall, and another 20 to 40% was severely damaged. For SW/A2 the exposed insulation remained attached to the wall for the remainder of the test. For PF/A2 and PIR/A2 the exposed insulation began to burn and fell from the

wall during the test. In both cases the masonry wall was exposed, between the combustion chamber and the top of the façade.

As a result of panel disintegration, the cavity barriers in those locations were ineffectual, failing to stop the spread of flame since they had no surface to seal onto. This is in disagreement with a medium-scale study by Guillaume et al., which found that cavity barriers performed well with ACM-A2 [16]. However, in that case the ISO 13785-1 test was followed, using a 100 kW heat source on a 2.4 m test rig. Another recent study found that when combustible insulation was used with ACM-A2 panels, twice as many horizontal cavity barriers were required to stop flame spread compared to non-combustible insulation [17].

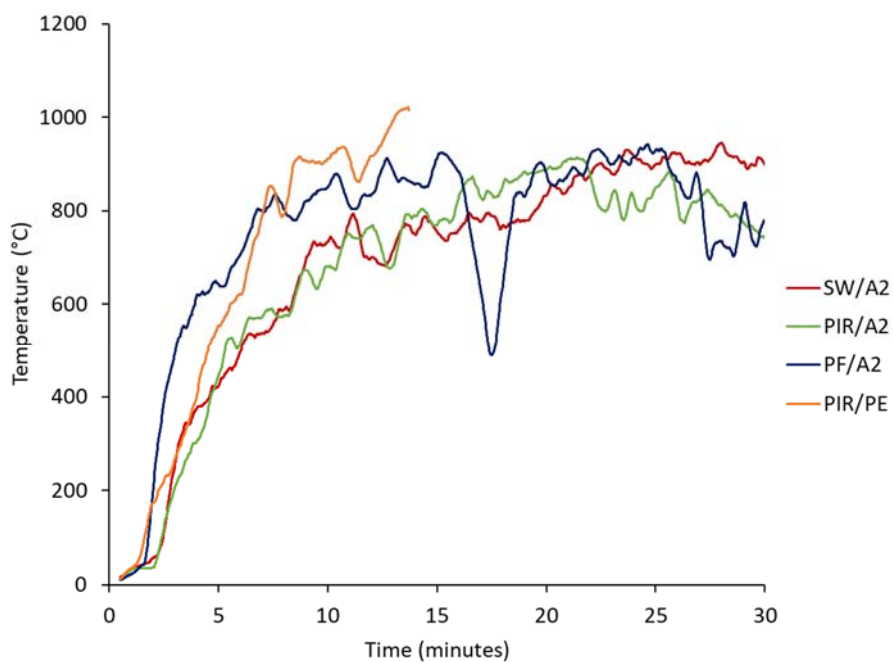
Figure 6 Temperature 50 mm outside façade, centre front face (TC1)

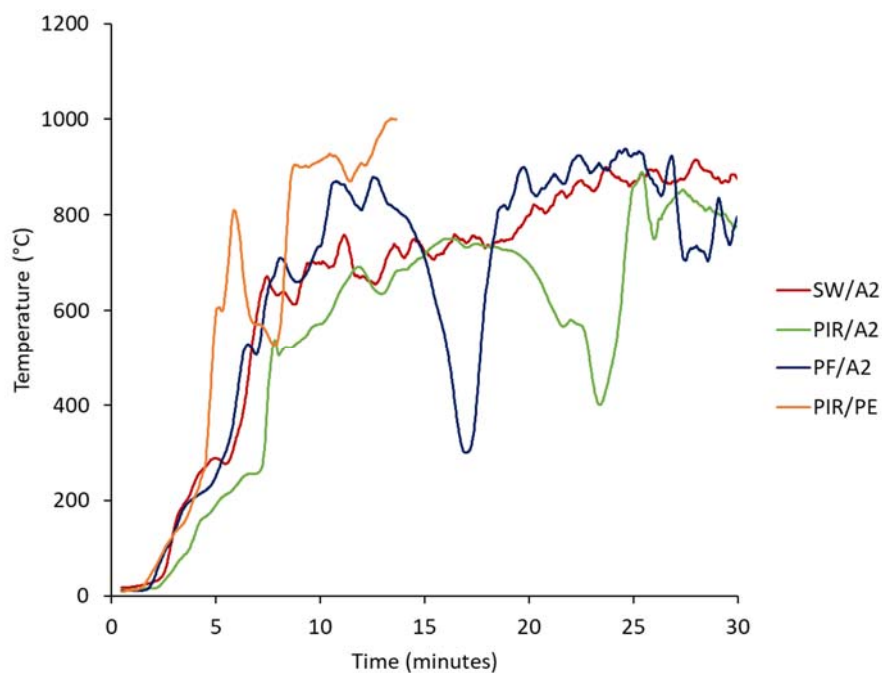
Figure 7 shows the temperature measured in the centre of the cavity, 2.5 m above the combustion chamber. This shows similar behaviour to the external thermocouple but provides insight into the behaviour within the façade. In general, at 650 °C the temperature variation is more erratic, corresponding to melting of the aluminium panels and brackets (at 660 °C) and exposing the thermocouple directly to the flame. The greater fire growth of the PIR/PE façade is evident before 5 min, and movement of the insulation slabs of PF/A2 (17 min) and PIR/A2 (23 min) appears evident. These times correspond to increases in temperatures of the thermocouples originally located in the mid-point of the insulation, seen in Figure 9. This movement is illustrated in Figure 8.

Figure 7 Temperature at midpoint of cavity (TC2)

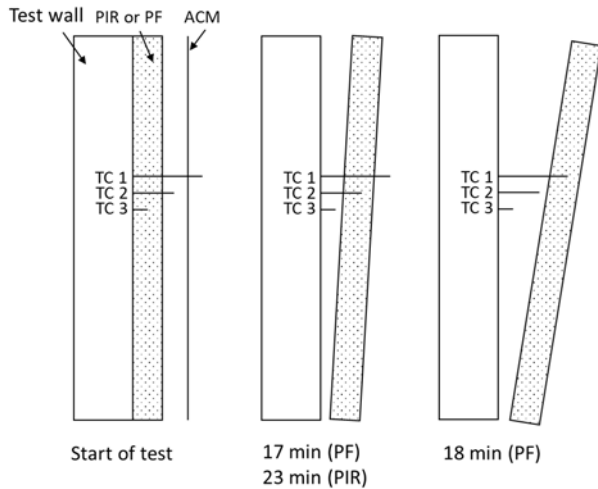
Figure 8 Movement of insulation panel to cover and expose thermocouples

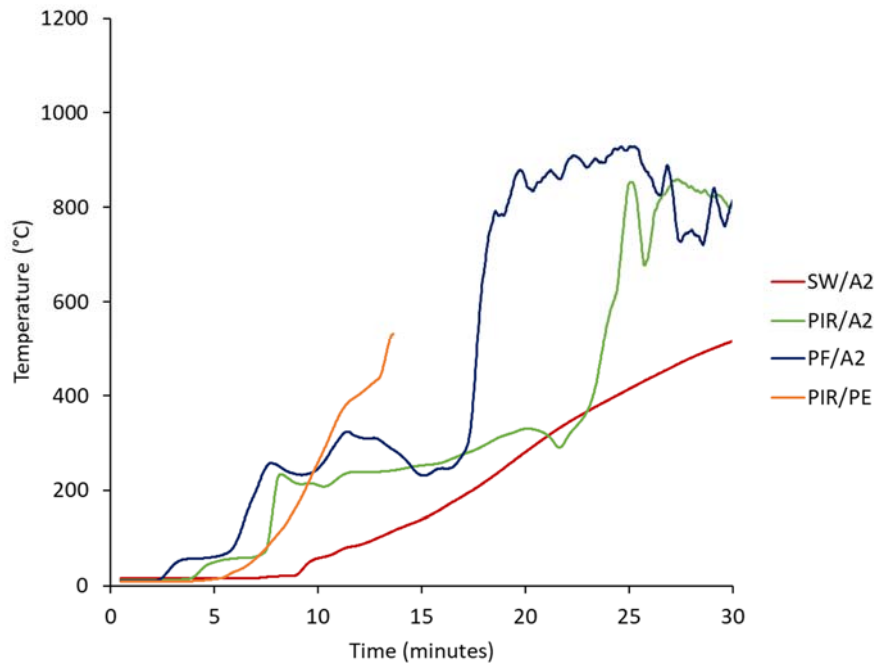
Figure 9 shows the temperatures measured at the midpoint of the insulation, 2.5 m above the combustion chamber. The data here show much clearer differences between the fire behaviour of the insulation products. The SW/A2 shows an expected progressive temperature increase, rising to 500 °C in 30 min, the insulation has remained in place, fixed to the wall. The movement of the combustible insulation slabs is also evident from the photographs in Figure 5. The foam insulation panels, which are superior insulators, show interesting three stage burning behaviour. In less than 5 min the temperature reaches 50 °C, then at 6 min (PF/A2) and 7.5 min (PIR/A2) the temperature rapidly rises to ~ 250 °C. Intriguingly, PIR/PE shows no two stage exothermic decomposition, possibly because of consumption of all available oxygen in the cavity by the burning ACM-PE. The temperature of the PIR/A2 and PF/A2 then rises gradually until the insulation falls away from the walls at 17 min (PF/A2) and 23 min (PIR/A2) (seen in Figs. 6 to 8). After that, the burnt insulation slab falls away leaving TC 3 completely exposed and the full flame temperature is reached.

Figure 9 Temperature at midpoint of insulation (TC3)

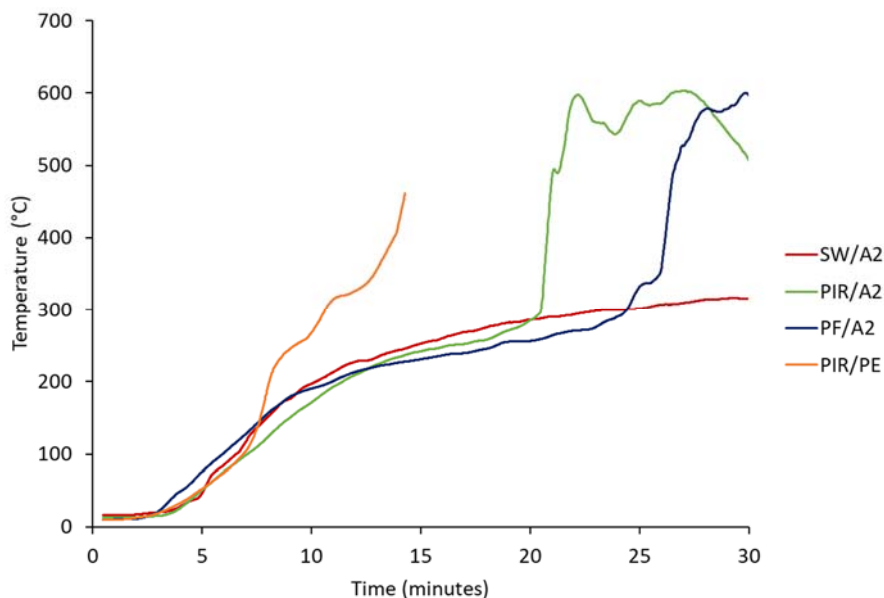
Figure 10 shows the temperatures in the kitchen vent duct. Superficially, the temperature profiles look similar to Figure 9, where closer inspection shows the PF/A2 and PIR/A2 rapid temperature rises have been reversed.

Figure 10 Temperature within Kitchen Vent (TC5)

It can be seen that once the fire reaches the section of the façade containing the vent, as the ACM panels disintegrate, the temperature sharply increases in the duct. The cavity barriers were ineffective without the ACM and the hot smoke and gases entered the vent section. The cavity temperatures are broadly similar for each test (~800 °C), but the temperature in the vent is much more dependent on the burning insulation within the façade and the presence of a vertical rail

which has helped to isolate the vent section. For PIR/PE, where the ACM panels and the insulation burnt most quickly, the temperature in the kitchen vent increased fastest of all the façades, reaching 450 °C in 13 minutes. For SW/A2, although the ACM panels above the combustion chamber melted and fell from the wall, the temperature in the vent only increased to around 300 °C, probably because the ACM panels and support rail isolating the vent section remained intact. For PIR/A2 the duct temperature increased sharply to 600 °C with the combined effect of the wood crib and burning insulation, around 2 minutes after the centre insulation slab fell from the wall, possibly due to the vertical aluminium rail melting as the temperature in the cavity increased. PF/A2 panels became dislodged after 17 minutes, and the temperature in the duct increased sharply to 600 °C after around 26 minutes. This delay in the temperature increase is probably due to the effect of protection from the vertical rail and dependent on the extent of insulation burning within the cavity since ACM panels around the duct remained intact.

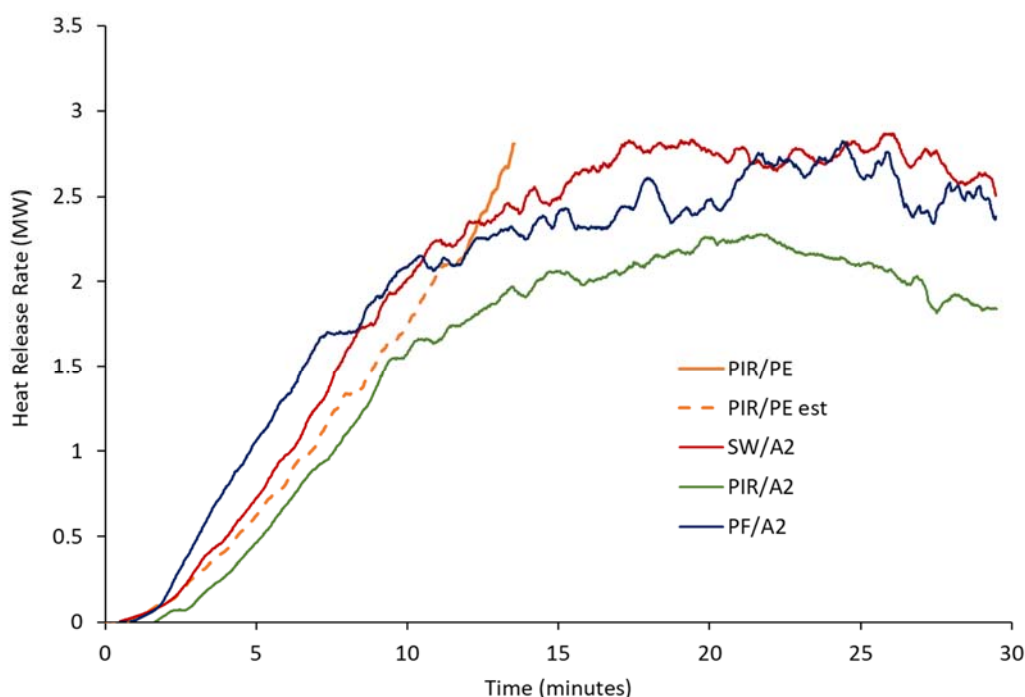
The temperature, oxygen concentration and effluent flow in the main extraction duct were measured for the first 30 min of the test. The large amount of water vapour resulting from extinguishment of the wood crib prevented meaningful data from being recorded after that time. These data have been used to calculate the heat release rate during each test, shown in Figure 11. Heat release rate has been calculated for PIR/PE based on estimated concentrations of oxygen up to 11.5 min.

Figure 11 Heat release rates

The calculated heat release rates (HRR) were within the range expected to be produced by the wood crib (a peak rate of  $3 \pm 0.5$  MW) [3]. The data show that for PIR/PE the heat release continued to increase after around 10 min, as the fire started to involve the façade products. In the other three ACM-A2 tests the HRR is dominated by the wood crib. Since significant burning of the PIR foam was observed, where the SW/A2 is essentially non-combustible, the SW/A2 heat release should be

smaller. However, the heat release rate measurements were dependent on the air velocity measurements in the duct ( $13.8 \pm 0.6$ ;  $13.8 \pm 0.6$ ; and  $14.8 \pm 0.8 \text{ m s}^{-1}$  for SW; PIR; and PF respectively) and the oxygen concentrations ( $13.4 \pm 0.3$ ;  $14.9 \pm 0.4$ ; and  $14.4 \pm 0.4 \%$  for SW; PIR and PF respectively) giving average HRR measurements and uncertainties of  $2.69 \pm 0.23$ ;  $2.12 \pm 0.22$ ; and  $2.51 \pm 0.27$  for SW; PIR and PF respectively. It appears that the measurement uncertainty was similar to the difference observed between individual façade products. The rank order heat release rate data is generally not in good agreement with the thermocouple data. This is likely due to entrainment of fresh air into the smoke extract system and would also be dependent on wind speed and direction on the day of the test.

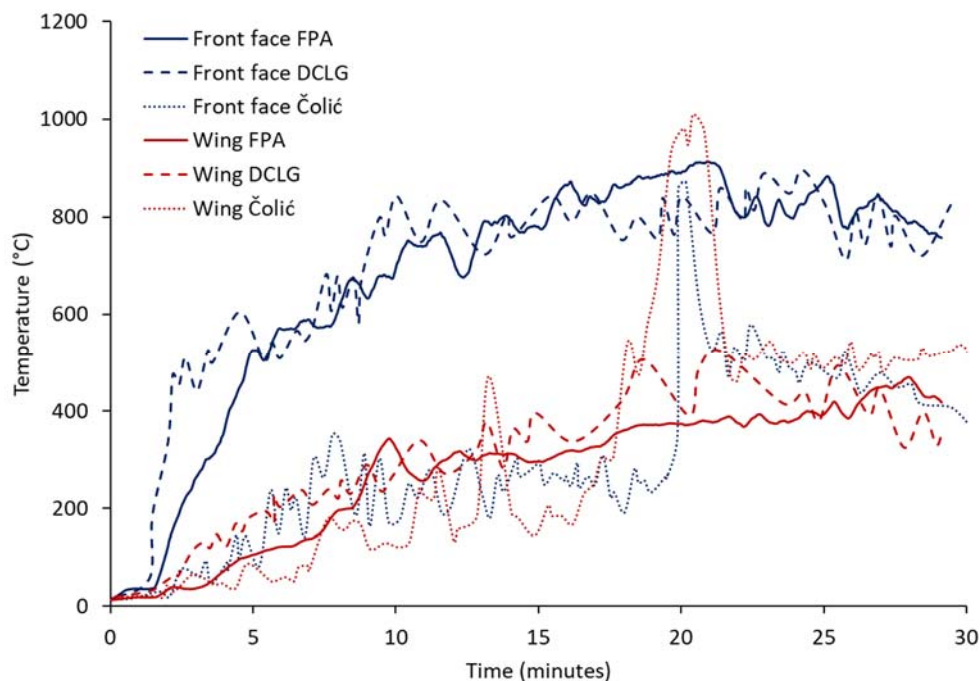
Figure 12 PIR/A2 FPA, DCLG and Čolić temperatures comparison [17, 19]

Figure 12 shows the level 1 temperature data for PIR/A2. Generally, for the DCLG and FPA tests the temperatures were similar throughout the first 30 min suggesting that the fire growth rate was similar, although the temperatures increased at a faster rate during the initial stages (2 to 5 min) for the DCLG tests. The Čolić data show a significantly lower front face temperature (albeit from a different test) than either the DCLG and FPA test data, followed by a sharp and short-lived increase at 20 to 21 min. This is likely to be due to the tests being conducted outdoors because the fire growth rate is highly dependent on wind speed and direction on the day of the test. In contrast, the wing temperature test data shows acceptable agreement between the three tests until 18 min when a similar short-lived increase is observed in the Čolić data. It should be noted that PIR/A2 passed the DCLG test and only passed the Čolić test with additional cavity barriers.

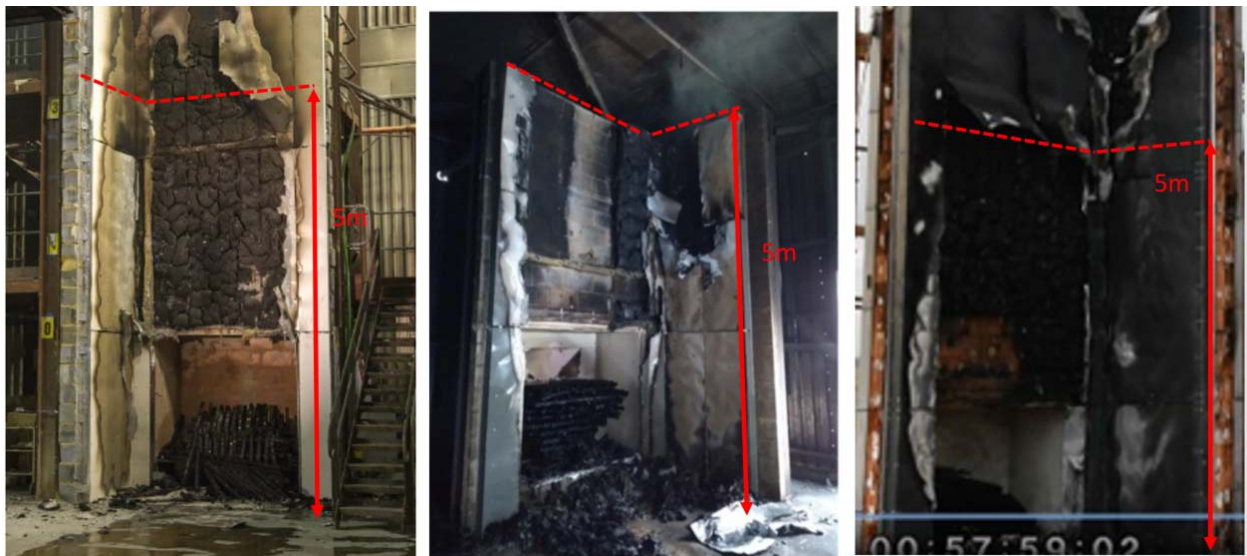
The photographs in Figure 13 show the burn areas for the FPA, DCLG and Čolić tests for PIR/A2. The burn areas show that the panels have burnt or fallen from the wall and failed to protect the underlying insulation from fire. The burn areas for all tests show that the damage is most severe in the area directly above the combustion chamber. In this area, the ACM panels are missing up to the 5 m point in all three tests. In the case of the DCLG test, charred PIR remains attached to the wall, suggesting more resilient mountings were used, whereas for our tests and the Čolić tests some PIR is missing and the masonry wall can be seen. Damage has occurred to the wings of all walls, most severe for our test where some of the ACM panels are damaged and partially missing, despite the lowest wing temperatures. The ACM on the wing of the DCLG and Čolić tests has been damaged on the surface, but has remained intact. The DCLG and Čolić test walls show that the damage to the wall, and missing ACM, above the combustion chamber extends beyond 5 m.

Figure 13 PIR/A2 comparison of burn area DCLG (left), FPA (centre) and Čolić (right) [17, 19]

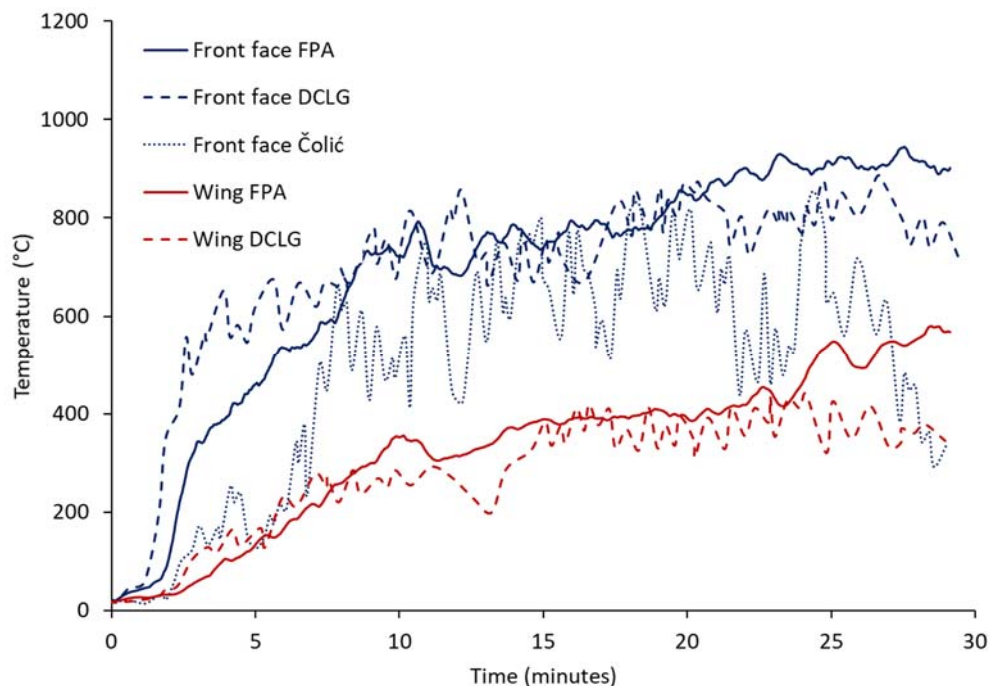
Figure 14 shows the temperature data for the current, DCLG and Čolić tests for SW/A2. The temperatures at the front face increased at a similar rate for all the tests, with the temperatures for the Čolić tests being lower towards the end of the 30 min period. Again, the temperature increased slightly faster in the initial stages (first 5 min) for the DCLG test. The wing temperatures were similar for our tests and DCLG tests throughout the 30 min period, no Čolić wing data was available for comparison.

Figure 14 SW/A2 FPA, DCLG and Čolić temperatures comparison [17, 20]

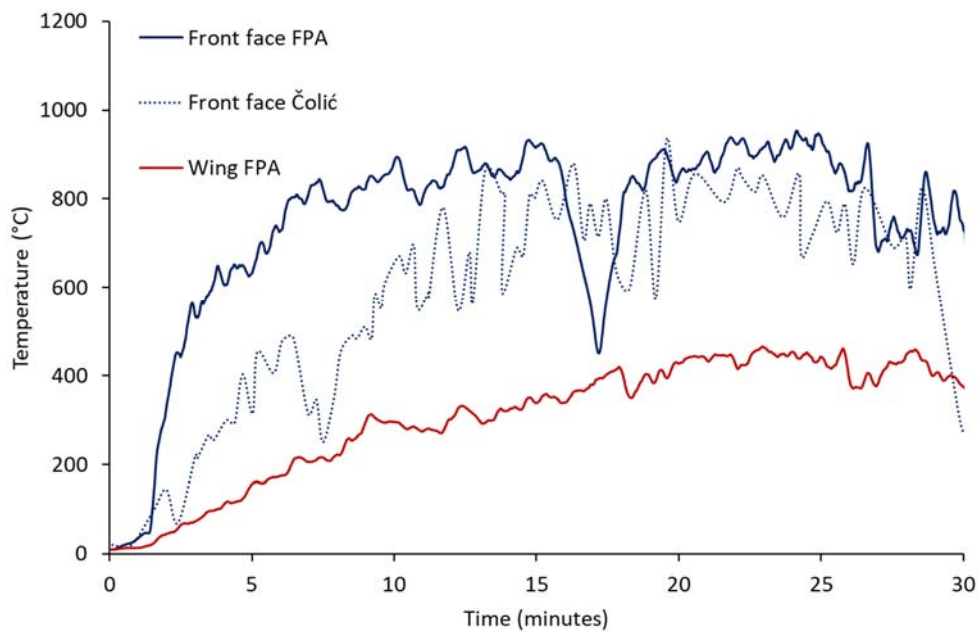
Figure 16 shows the temperature data from the current study and Čolić. The front face temperatures were lower in the initial stages for Čolić but similar after the first 15 min. No Čolić wing data was available and DCLG did not carry out a test of this combination. This combination of PF/A2 only passed the Čolić test when additional cavity barriers were used.

Figure 16 PF/A2 FPA and Čolić temperatures comparison [17]

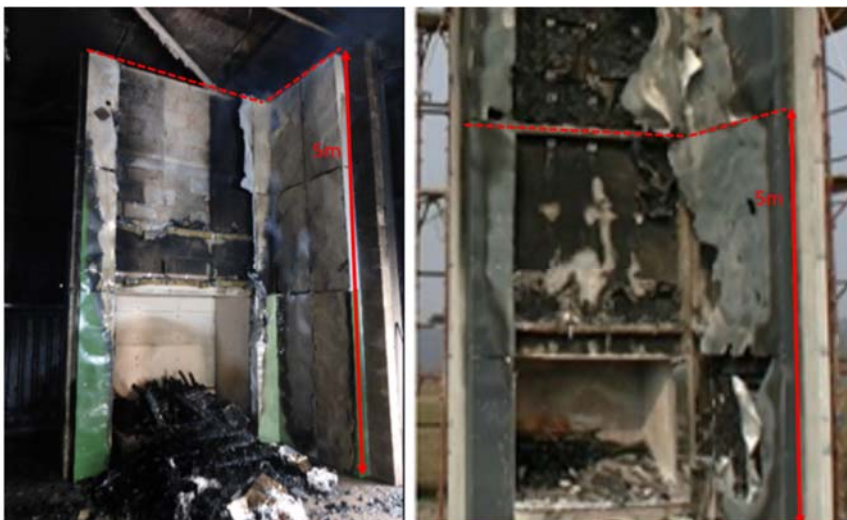
The photographs in Figure 17 show a similar pattern of damage to both façades. The area directly above the combustion chamber has suffered the most damage, with ACM panels and PF insulation having fallen from the walls during the tests. The Čolić façade shows the damage extending well above the 5 m mark. The FPA wing has been damaged but the ACM has remained in place, however, some of the ACM has started to detach from the wing of the Čolić façade.

Figure 17 PF/A2 comparison of burn area Čolić (left) and FPA (right) [17]

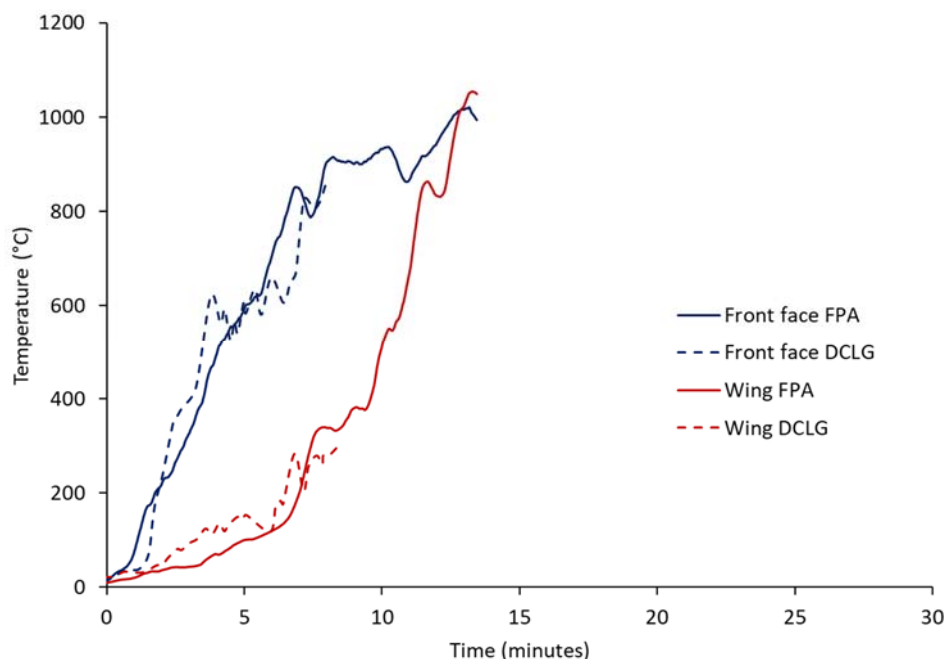
Figure 18 shows that the temperature increases at both the centre of the front face and the wing were similar for the duration of the tests. This material combination of PIR/PE resulted in temperatures increasing at a faster rate than for any other test. The DCLG test was stopped sooner (8 min) than the FPA test (13.5 min), but the data show that the fire growth was similar for the first 8 minutes of both tests.

Figure 18 PIR/PE FPA and DCLG comparison [18]
