| Title | Modelling, identification and structural damage investigation of the Neoria monument in Chania |

# Modelling, identification and structural damage investigation of the Neoria monument in Chania

The structural behavior of Neoria masonry monument is studied here. The determination of structural and material properties of a partially collapsed monument and the evaluation of existing damages and their importance for further restoration studies are not trivial tasks. The investigation has been based on detailed geometric data, collected from sources and in-situ measurements. For the mechanical analysis, finite element models have been created with different level of detail, including simplified description of documented damages. Modal analysis is assisted by micro-tremor measurements. Comparison of the predictions with the experimentally measured quantities, allows the determination of material parameters with higher accuracy. A least square technique assisted by the modal assurance criterion has been used, by driving the model from a Python script. A comparison of collapse predictions based on modified pushover analysis, with classical modal analysis has been performed. An

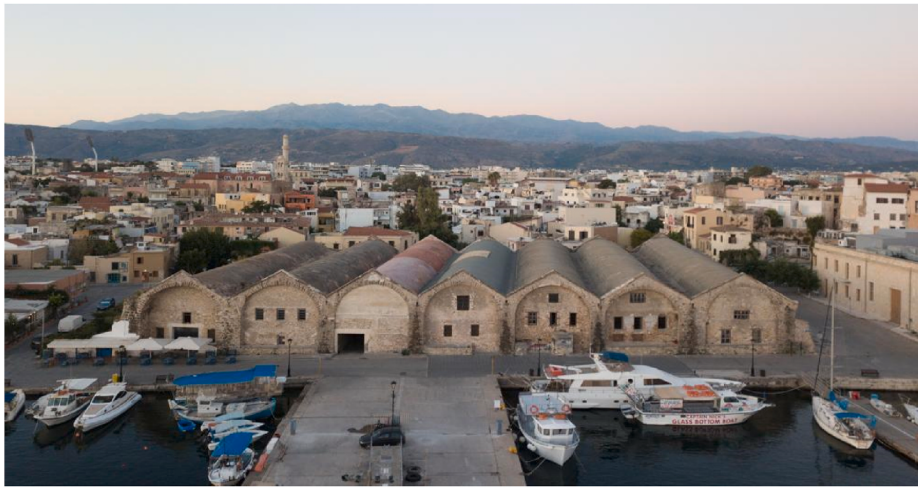
Fig. 1. The Neoria monument (Providakis, 2021).

In the present paper, the structural analysis investigation of the Neoria masonry vaulted structure at the Venetian harbor of Chania is presented (Fig. 1). Data related to the structure, the material, the damages and the foundation have been collected during a recent research project (Providakis, 2021). The accurate representation of the geometry of the vaults and the spandrels is necessary in order to model the existing condition including permanent deformations, loose material, cracks (Stavroulaki et al., 2016). This is important for the estimation of the structural strength and dynamic behavior considering the three dimensional, effects of the vaults and the stabilization role of the spandrels (Stavroulaki and Tsinarakis, 2011).

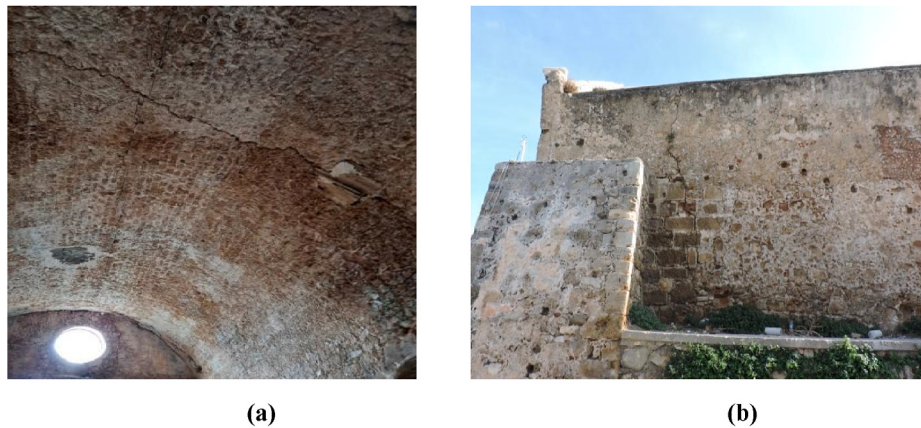
**Fig. 12.** Crack on vault. (a) Inside and (b) outside view. (c) Biological deterioration on the North Wall.

Large width cracks of the inside of the vaults and on the west wall are illustrated in the followed Figures (Fig. 12 (a) – (c))

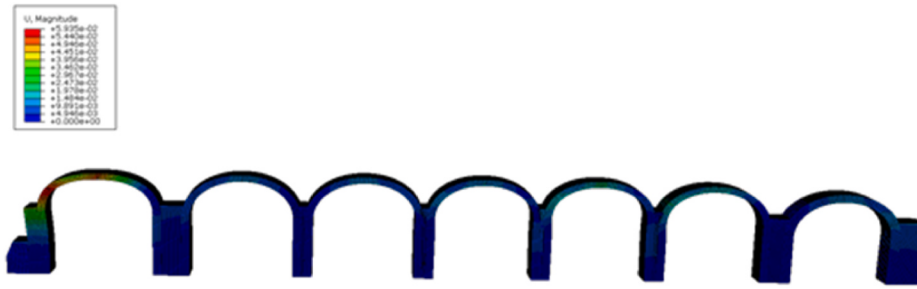
Fig. 19. The displacement contour of the whole structure under gravity loads.

closure and sticking-slipping along the masonry stone interfaces. The models were developed with a fixed support and the self-weight was incorporated in the loading condition. Two steps were used to create the models: the first step was a pure gravity load to simulate the state of inertia of the structure and to stabilize the model. The second step has an increased gravity load by 0.5g which was incrementally applied on the structure. This is used to provide a preliminary indication of the effect of the vertical component of an earthquake to the structural system. The results from these models are shown in Figs. 18–20.
