R
e
d
u
c
t
i
o
n
o
f
L
o
a
d
C
a
p
a
c
i
t
y
o
f
S
c
r
e
w

10.0007/s10694-018-01841-8 © Springer 2018

The load capacity of screw fixings supporting building services, such as sprinklers in Cross Laminated Timber (CLT) ceilings was tested before, during and after exposure to fire, to investigate the risk of detachment. The pull-out strength of screw fixing in ambient conditions, during and post-fire were investigated in relation to pull-out strength versus embedment depth. The relationships between pull-out strength have been reported as functions of screw fixing embedment depth, screw dimensions, and char formation. In the experimental study, samples of standard industrial CLT were tested with two distinct types of adhesives with typical construction industry screw fixings used for the suspension of Mechanical and Electrical (M&E) services. A purpose built fire-test rig was designed to expose screw fixings embedded into CLT to a fire in a ceiling mounted configuration. A series of eight fires were conducted, and the pull-out strength of each screw fixing was assessed during or after the fire. The reduction of load capacity can be conceptualised into two factors: The charring acr

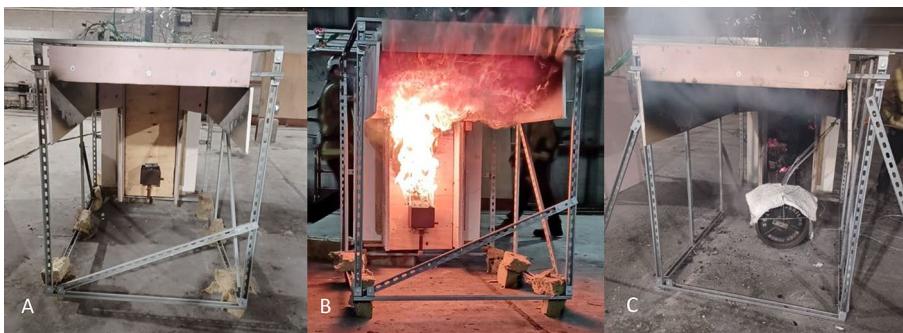
Fig. 1 The fire test rig. **A** Pre-fire, **B** During testing, and **C** Post-fire

A medium-scale test rig was developed incorporating CLT test panels with a wall to ceiling interface which subjected the panels to a 100 kW fire from the burner as shown in Fig. 1. The scale of the test rig allowed for exposure of an area measuring 0.81 m² of ceiling in which to insert multiple test screw fixings. The primary heat source was a 170 × 170 × 170 mm gravel bed gas burner (as specified in ISO 9705 [69]), fuelled with propane gas via a Bronkhorst mass flow controller at a constant 100 kW. This was placed in contact with a vertical backing wall comprising sheets of 18 mm plywood which were gradually consumed during testing. This, together with a sacrificial section of CLT directly above the burner, helped ensure that the test samples of CLT were fully exposed to flames throughout the tests.

See Fig. 1 shows the test rig which measured 2050 mm (L) × 1200 mm (W) × 1450 mm (H) overall. To ensure flames were channelled up the rear wall to the underside of the ceiling, and minimise the influence of draughts within the laboratory, the burner was framed with vertical plasterboard baffles. Full design of the test rig is shown in Fig. 2.

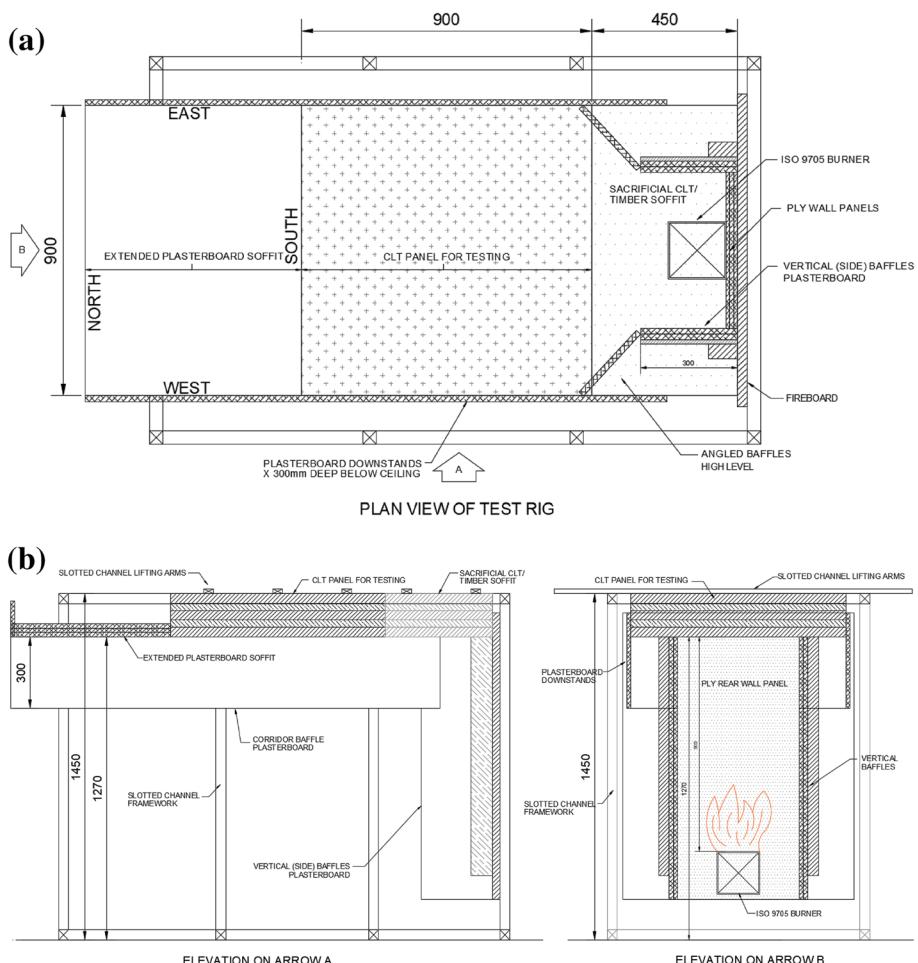
Fig. 2 Design of the bespoke test rig. Plan view and elevation on arrow 'A' and 'B.'

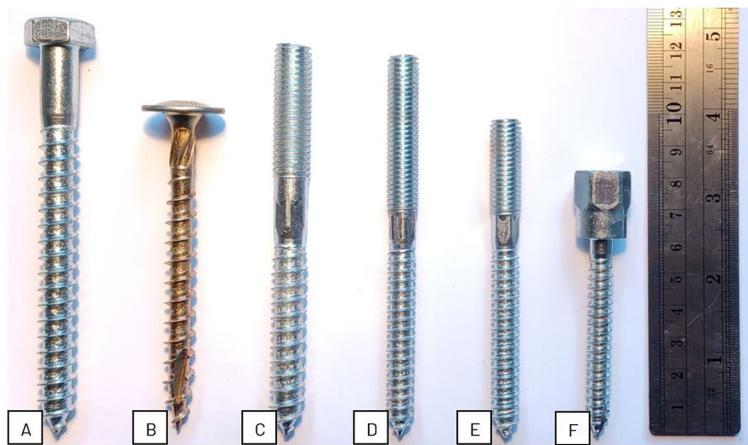
Fig. 3 Screw fixings tested **A**—M12 coach screw, **B** – M10 (M8) coach screw, **C** – M12 stud screw, **D** – M10 stud screw (long), **E** – M10 stud screw (short) and **F** – M10 rod hanger (M6 thread) supplied by Midfix

Standard hanger-type industrial screw fixings, known as stud screws and rod hangers (M10 and M12), shown in Fig. 3 (C, D, E and F) were evaluated at their full embedment depth of 60 mm and smaller 8 mm (M8) coach screws in the same configuration as Fig. 3 (B) at 100 mm long embedded to 90 mm.

Screw fixings A, C, D, E and F are carbon steel with zinc coating to a thickness of 5 μm . Screw fixing B is hardened carbon steel, finished in zinc plating with a yellow chromate passivation to a thickness of 5 μm . It is acknowledged that there are a multitude of different screw types for use in timber that have different shank to thread ratios, including pitch angle and tip shapes.

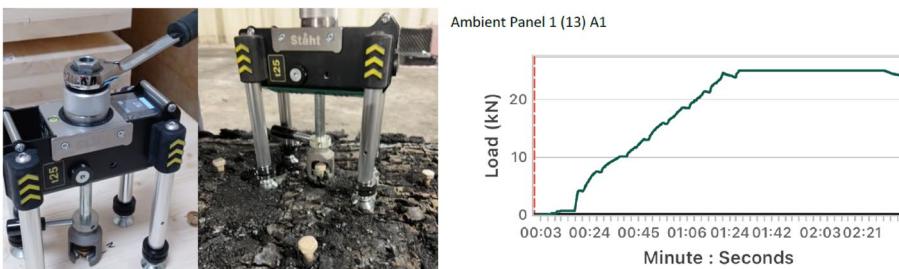
Fig. 4 Staht t25 digital pull tester device at ambient and post-fire testing with individual result print-out

With screw fixings inserted into the samples, pull-out forces were recorded for all CLT panels. Figure 4 shows load testing conducted using the Staht t25 digital pull tester to BS 8539 [24].

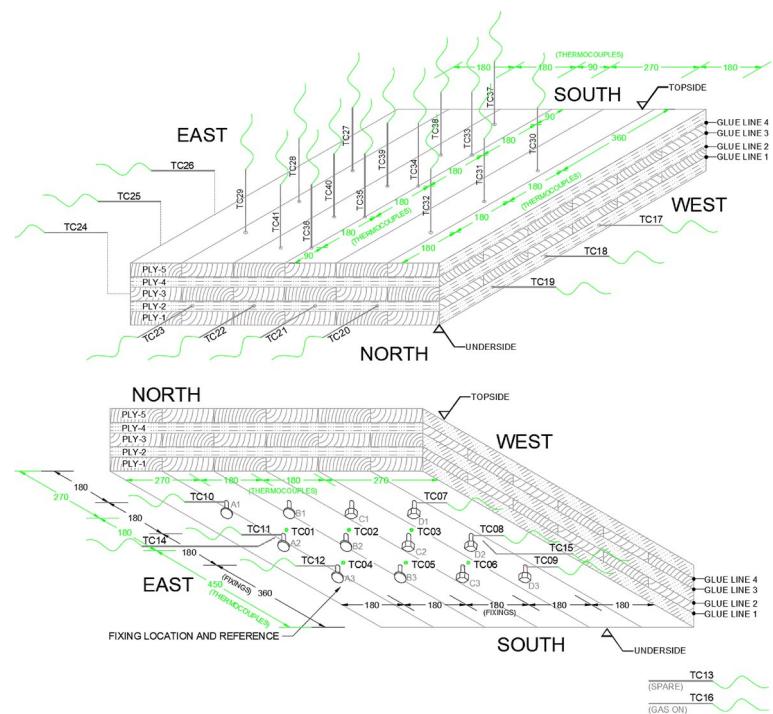
Fig. 5 Locations of thermocouples, Top: Internal locations. Bottom: Exposed/below the CLT panel. The depth of the thermocouples is detailed in Table 3

Eight panels were fire tested incorporating screw fixings, and 41 mineral insulated type 'K' thermocouples, 1.5 mm dia \times 300 mm long, were installed in locations below and within the CLT panel as shown in Fig. 5 and Table 3. Thermocouples were installed parallel and perpendicular to the exposed heated surface to record ceiling gas, screw (tip, mid-point, head), glue line and general ply temperatures. It is acknowledged that thermocouple output can be impacted through installation positions and orientations [71–73]. With the exception of gas measuring thermocouples, all other thermocouples were installed on the non-fire side to reduce errors associated with conduction along the metal sheathing. To ensure thermocouples were touching the fixings at the mid-point and the tip, a jig was used for drilling accuracy until the drill tip contacted the embedded fixing. The thermocouple was then fully inserted, and contact was confirmed by metal-on-metal sound. The thermocouple was then retracted and insertion depth compared through measurement against drilling depth as a secondary check. Durations for fire testing were 30 and 60 min.

Gas/flame temperatures were measured 15 mm below the wood sample around the screw fixings shown in Fig. 5, (TC01 – TC06 inclusive). Temperature results for fire tests were all very similar. Figures 9 and 10 show average temperature data consistent with a fully developed compartment fire (i.e. >600 °C). Temperatures were approximately consistent for 30 min for tests FT1, FT2, FT3, FT6 & FT7 and 60 min for tests FT4, FT5 & FT8. Gas temperatures were observed to be around 100 °C greater closer to the burner at TC04, 05 & 06, than those further from it at TC01, 02 & 03. This resulted in lower pull-out forces for

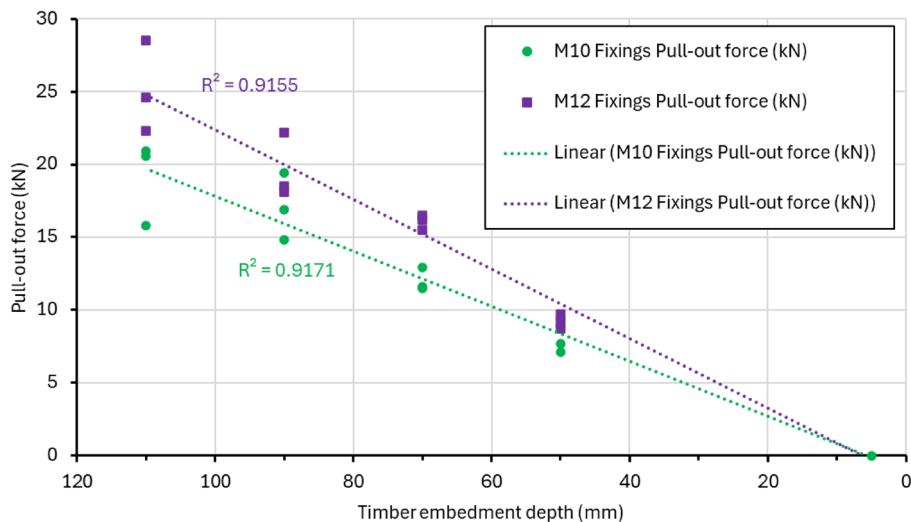
Fig. 6 Pull-out force versus embedment depth for HB S adhesive, ambient conditions

Pull-out forces measured as a function of embedment depth are shown in Figs. 6 and 7. These illustrate the positive linear relationship between pull out force and embedment depth for the two panel types and two coach screw diameters. The increased pull-out resistance of the M12 coach screw relative to M10 coach screws is also evident for embedment depths

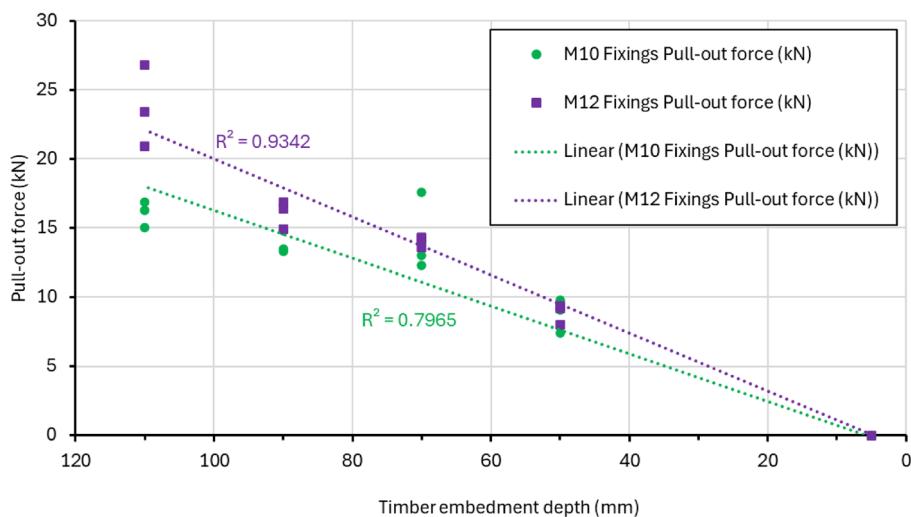
Fig. 7 Pull-out force versus embedment depth for HB X adhesive, ambient conditions

greater than 50 mm. It is apparent that there is very little difference in results between the two different adhesives shown in the graphs.

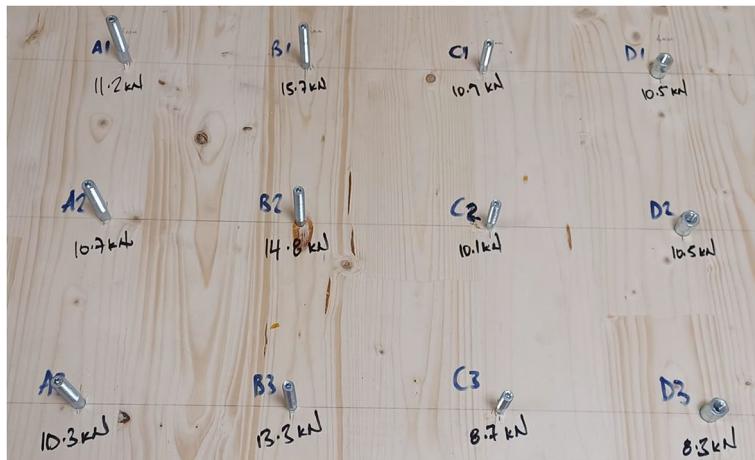
Fig. 8 Standard Industrial-type screw fixings for M&E services (ambient conditions) (A1-3 M12 stud screw, B1-3 M10 stud screw-long, C1-3 M10 stud screw-short, and D1-3 M10 rod hanger)

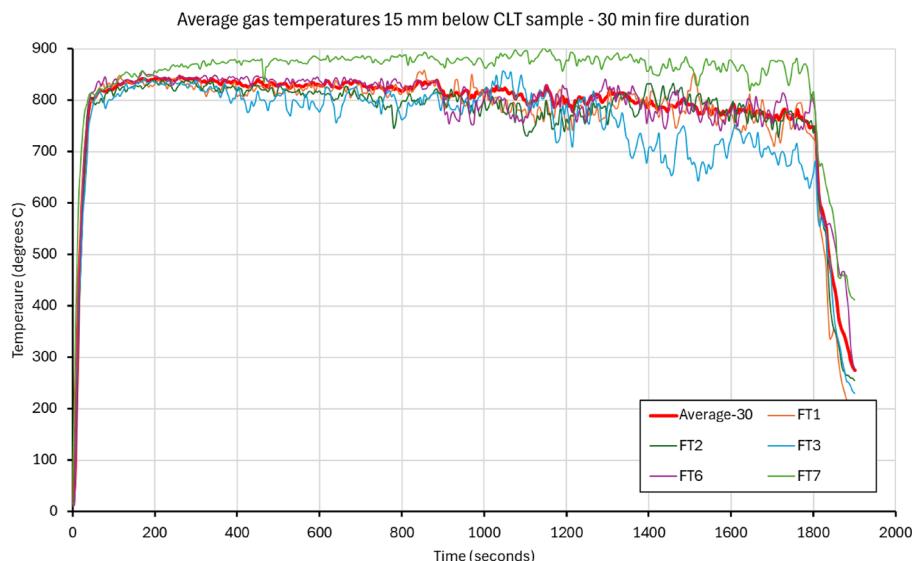
Fig. 9 Average gas temperatures measured 15 mm below the underside of the CLT sample for 30 min, tests (FT1, 2, 3, 6 and 7)

It can be seen from Fig. 9 that the temperature for FT3 is lower than other 30 min fire tests. This was caused by frost developing on the cylinder affecting gas flow through the mass flow controller, causing a drop in output temperature ($< 100 \text{ kW}$) from the burner at $\sim 700 \text{ s}$. FT7 shows a higher temperature output which resulted from warming the cylinder during the test, providing a very steady burner output of 100 kW.

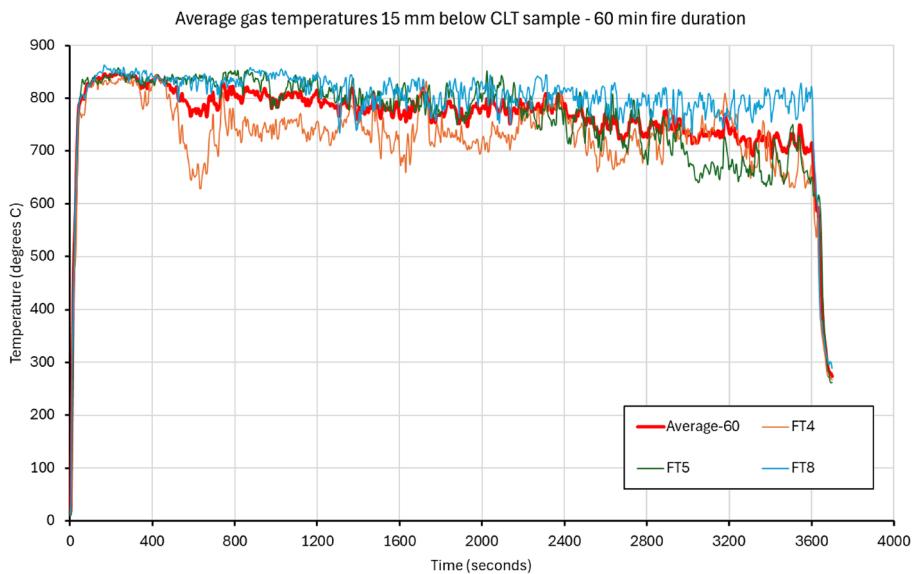
Fig. 10 Average gas temperatures measured 15 mm below the underside of the CLT sample for 60 min, tests (FT4, 5 and 8)

Test FT4 shows a lower than average gas temperature for the 60 min duration and a drop off at $\sim 500\text{--}700 \text{ s}$. Burner output remained constant at 100 kW for 45 min until a drop off due to frost build up on the cylinders. The drop off at $\sim 500 \text{ s}$ could potentially be due to early char formation slowing contribution from the wood, but this is not proven in these experiments.

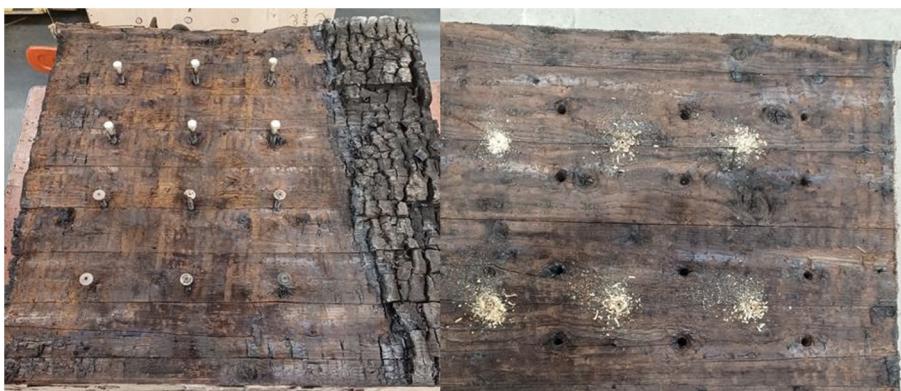
Fig. 11 CLT panel with the char removed around the screw fixings (left) and pilot drill holes for remaining slab thickness measurements (right)

Char depths were measured following pull-out tests. Each sample had char carefully scraped away as shown in Fig. 11, using a wallpaper scraper and hand brush. To determine embedment depth on the resulting uneven surface, pilot holes were drilled through the full depth of the sample and measurements were taken of the remaining timber depth to provide char depth measurements shown in Fig. 18, not dissimilar to the procedure used by Brandon et al. [77].

Tests FT1, 2, 3, 4, 5 and FT8 utilised coach screws shown in Fig. 11. A consistent temperature rise from exposed screw head shank to the embedded screw tip was observed as shown in Table 7 and Fig. 18.

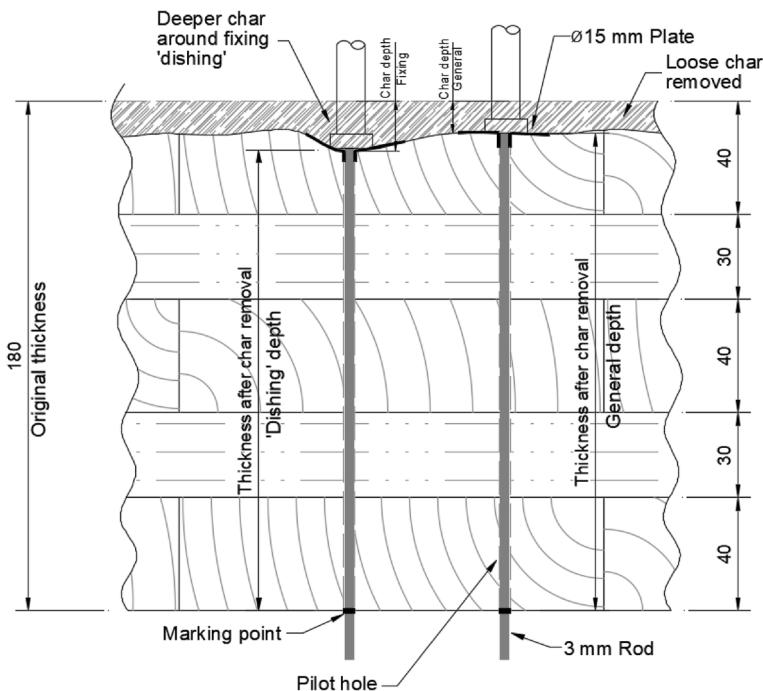
Fig. 12 Shows how the char depths were measured with a 3 mm diameter rod pushed through pilot holes to the 15 mm diameter plate with marking point

Measuring consisted of using a 3 mm diameter rod pushed through the pilot hole to a small flat circular plate $\sim 15 \text{ mm}$ diameter that sat on the face of the charred surface. The

depth of insertion from the opposite face from the fire was marked on the rod then measured and recorded with digital callipers. Where screw fixings were removed from the sample, the circular plate was inserted into the depth of the ‘dishing’ and the same measuring principal applied. Figure 12 shows the details for char measurements taken.

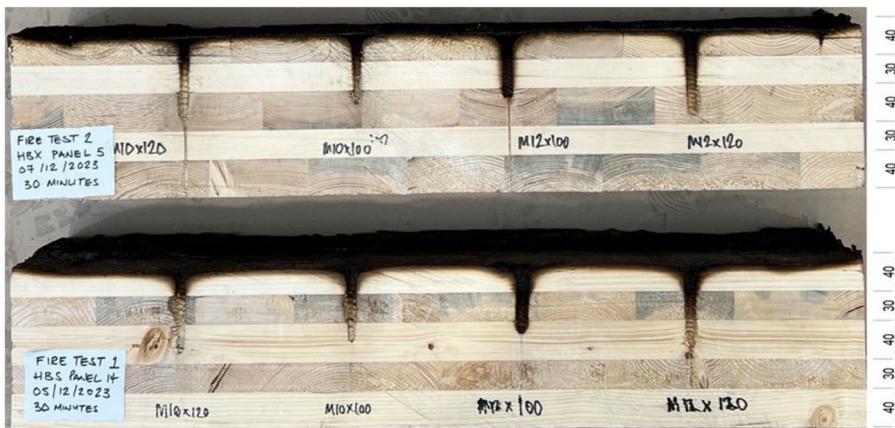
Fig. 13 Cross section of tests FT1 and FT2 showing loss of material at the surface of the CLT panel and the 'dishing' effect localised around the screw fixings after 30 min fire exposure

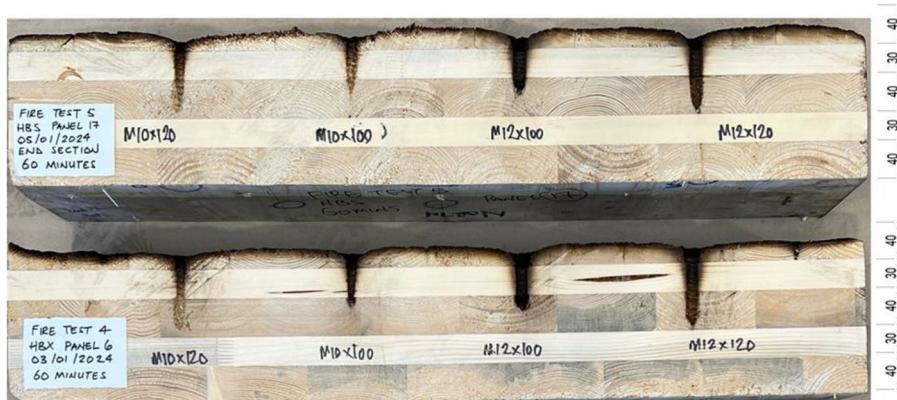
Fig. 14 Cross section of tests FT4 and FT5 showing loss of material at the surface of the CLT panel and the ‘dishing’ effect localised around the screw fixings after 60 min fire exposure

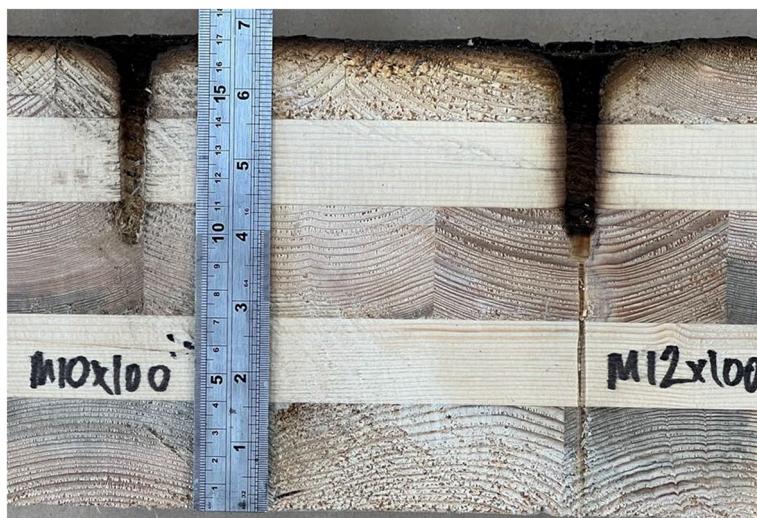
Fig. 15 Enlarged view of internal charring through heat conduction at the coach screws

Figure 15 shows a close-up of the charring effect of heat conduction through the screw fixings, with greater charring at the M12 coach screws than the M10 coach screws, which was observed across all fire tests. The M10 coach screw shows partial charring through the screw embedment and rupture of the wood fibres towards the location of the tip.

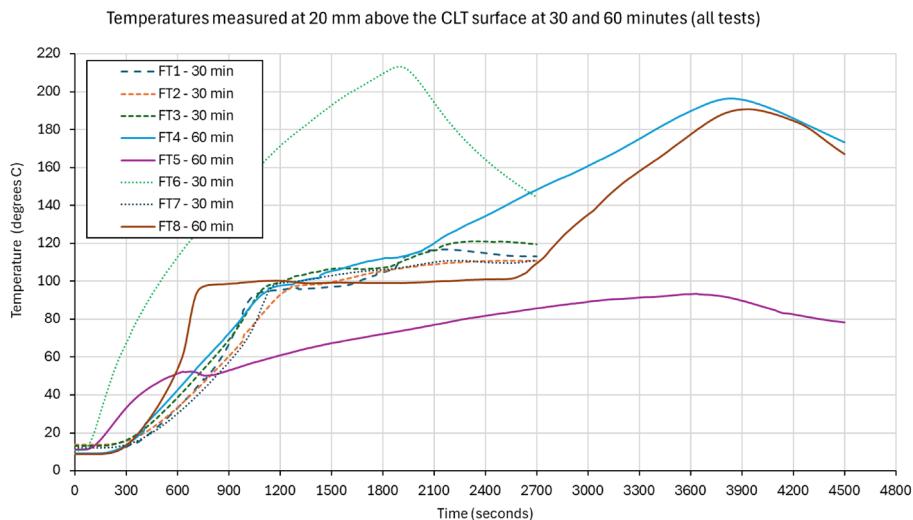
Fig. 16 Measurements of temperature within the CLT test sample at 20 mm above the exposed CLT surface at 30 and 60 min

Measurements within the sample show an increase in temperature in all 5-ply layers. After cut-off of the burner gas supply, internal temperatures continued to rise slowly which may contribute to further loss of load capacity post-fire extinguishment. This can be seen in Fig. 16 for measurements at 20 mm above the exposed CLT and is consistent with findings by Gernay et al. [50] with general locations of thermocouples shown in Fig. 17. It is also noticeable for tests FT1, 2, 3, 4, 7 and 8 that temperature remains at a constant 100 °C for a period of time, until the moisture is driven off, before temperature starts to increase. Tests FT5 and FT6 show inconsistent results which could be due to the inconsistencies in CLT moisture condition at the time of the test.

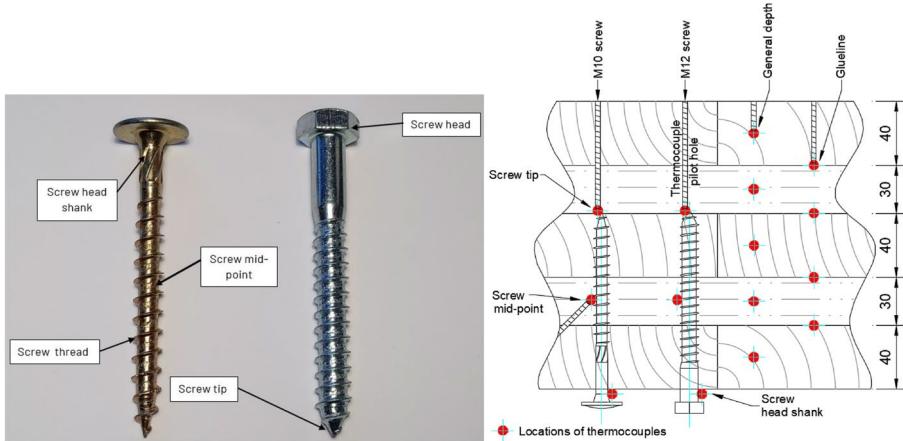
Fig. 17 Shows coach screws under test (left) and locations for thermocouples at different screw fixing locations, general ply depths and glue line (right)

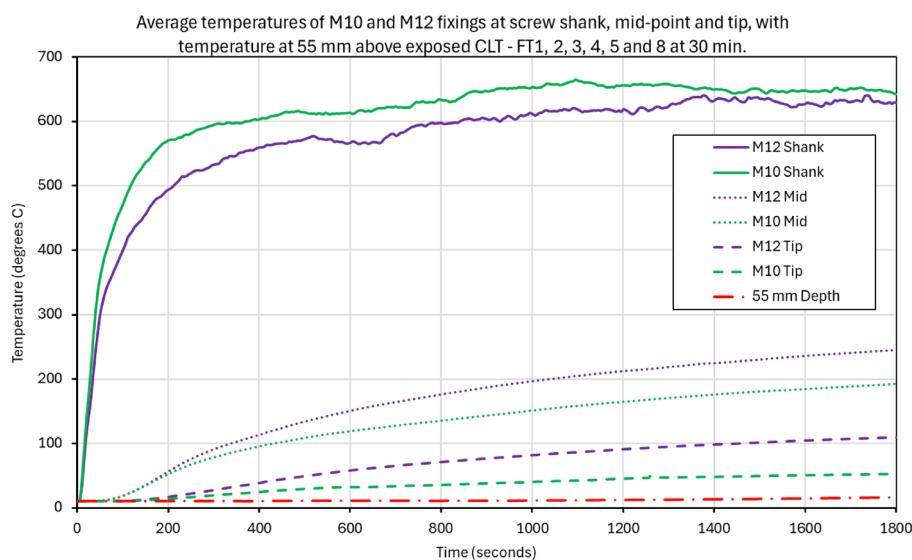
**Fig. 18** Average screw fixing temperatures recorded as a function of depth at the CLT (screw shank), at the mid-point (internal) the screw tip (internal) and at 55 mm above the exposed CLT at 30 min

Measured temperatures at the screw head shank, mid-point and tip for coach screws (M10 and M12) for tests FT1, 2, 3, 4, 5 and 8 are shown in Table 7 and Fig. 18 at 30- and 60-min fire durations. At 30 min, screw head shank temperatures ranged from 554–717 °C, mid-point ranged from 133–292 °C, and tip ranged from 42–167 °C, with an average gas tem-

perature ranging from 658—811 °C. At 60 min, screw head shank temperatures ranged from 583—690 °C, mid-point ranged from 243 – 345 °C, and tip ranged from 57—127 °C, with an average gas temperature ranging from 651—823 °C. In stark contrast to the lower thermal conductivity of timber, much higher temperatures were reached adjacent to the screws which would account for the degradation of the load capacity of the timber as detailed by Khelifa et al. [74]. The mid-point screw temperatures at a depth of 55 mm, are observed to be much greater than for the timber at the same time and depth shown in Table 7 and Fig. 18. Measurements within the timber confirm larger diameter M12 screws consistently result in higher temperatures than M10.

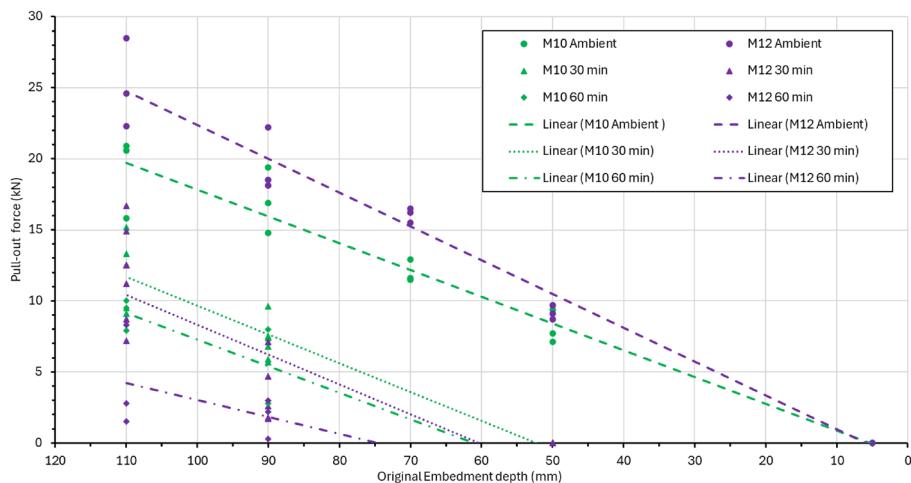
Fig. 19 Pull-out force versus embedment depth for HB S adhesive, ambient conditions, 30 and 60 min fire exposure

Comparison of the two graphs (Fig. 19 and 20) show a similar relationship in loss of load versus embedment depth. Above 50 mm embedment and at ambient conditions, M12 screw fixings having a greater load capacity than M10. However, post-fire results indicate the opposite, M10 screw fixings retain a greater load than M12. This result might seem counter intuitive but is believed to result from greater heat transfer into the CLT through the wider screws resulting in higher temperatures at the interface between the thread and the timber leading to charring and loss of strength. The steeper slope of the post-fire tests shows the increased beneficial influence of embedment depth on the load capacity.

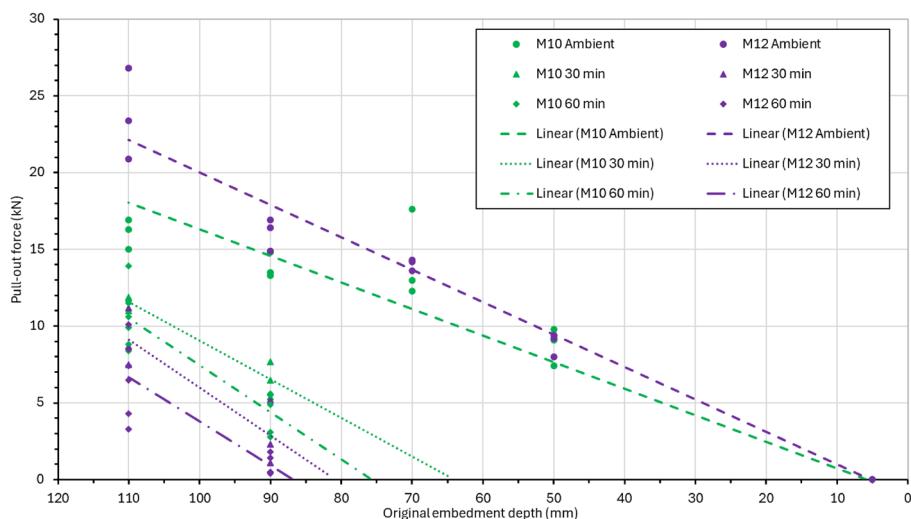
Fig. 20 Pull-out force versus embedment depth for HB X adhesive, ambient conditions, 30 and 60 min fire exposure

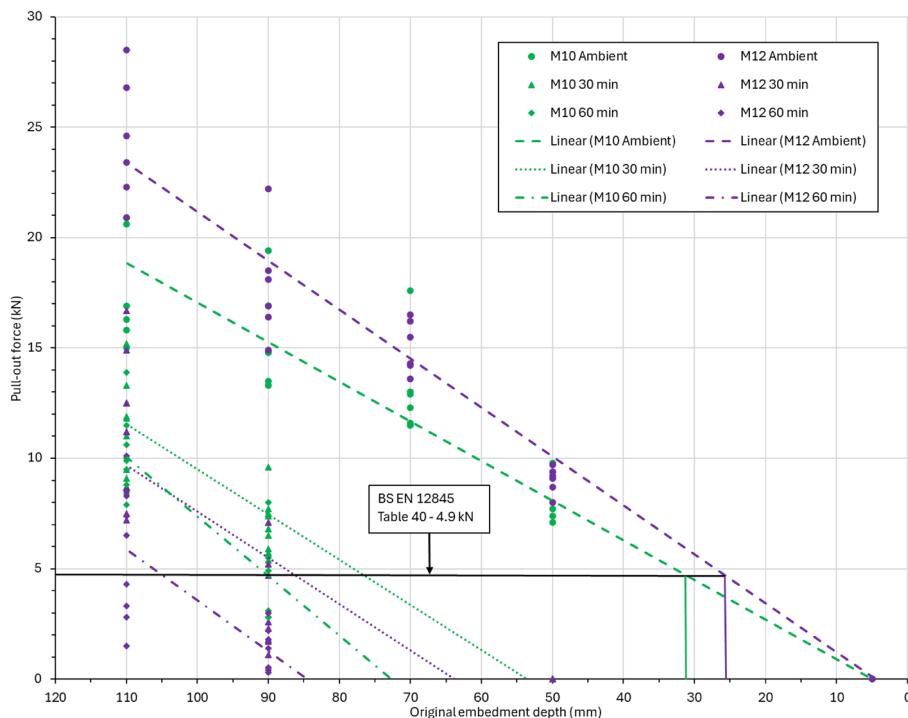
Fig. 21 Pull-out force versus embedment depth, all results, ambient conditions, 30 and 60 min fire exposure

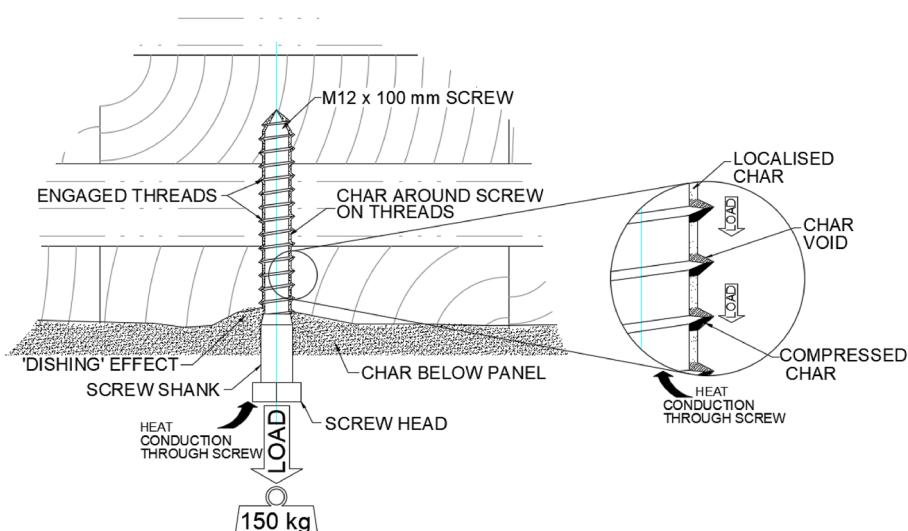
Fig. 22 Shows a coach screw under load, heat conduction through the fixing leading to char formation at the contact point between screw thread and timber
