# An investigation of oil leakage from automotive driveshaft radial lip seals

Petros Nomikos<sup>1,2</sup>, Ramin Rahmani<sup>1</sup> , Nicholas Morris<sup>1</sup>   
and Homer Rahnejat<sup>1,3</sup>

Proc IMechE Part D:  
J Automobile Engineering  
1–17

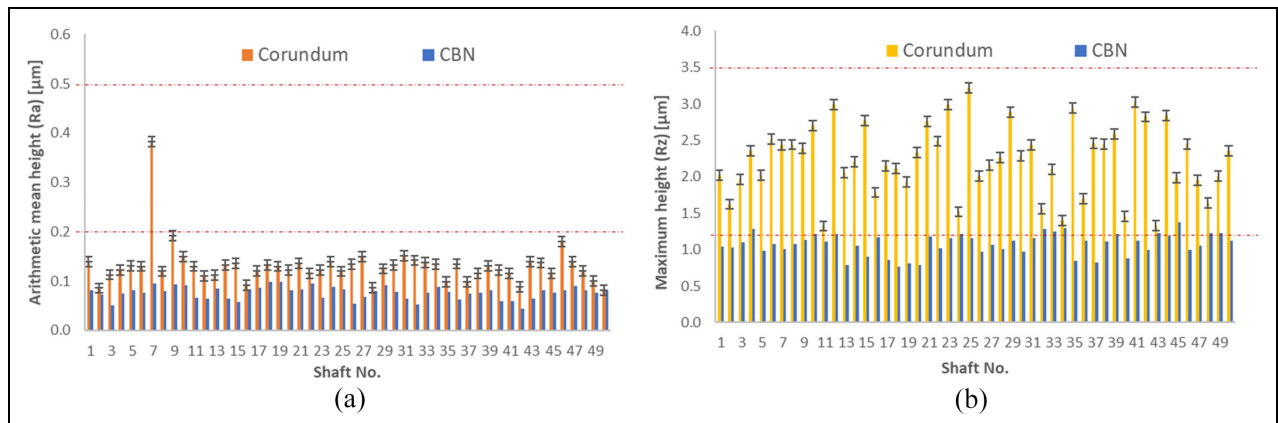
**Figure 5.** Measured (a) Ra and (b) Rz.

The measured surface quality of the shaft sealing seats for  $R_a$  and  $R_z$  can be obtained, using Figure 5(a) and (b). In Figure 5, all the measured  $R_a$  values are given within the tolerance range for corundum and

CBN grinding in the industrial standards such as DIN 8589-14.<sup>36</sup> Approximately, the same condition applies for the  $R_z$  values measured for the tested shaft specimens in Figure 5(b). It is clear that the tolerance range for  $R_z$  is utilised to a greater extent, but still within the desired range. Several measured values can be found at the upper tolerance limit. Additionally, it is noticeable that there is a greater spread of values for  $R_z$ . Thus, overall, both manufacturing processes fulfil the required surface specifications set by the appropriate standards. It can also be seen that in comparison to the

corundum ground shafts, the CBN ground shafts show lower Ra and Rz values with a lesser spread in their topographies.

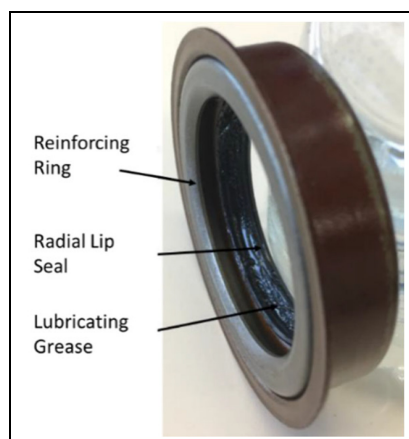
**Figure 6.** Radial lip seal ANIS-I 177-I 543 933.

An example of radial shaft seals used during the experiments is shown in Figure 6. This type of seal is coated before the test-runs with a sealing paste pressed onto the test flange of the rig. This action is essential in order to ensure that no lubricant can ingress in between the outer diameter of the rotary shaft seal and the inner diameter of the test flange. The rotary shaft seal is equipped with a reinforcing ring, containing an elastomeric sealing material. Each sealing ring is greased to prevent a dry run-in start-up or stop conditions. For

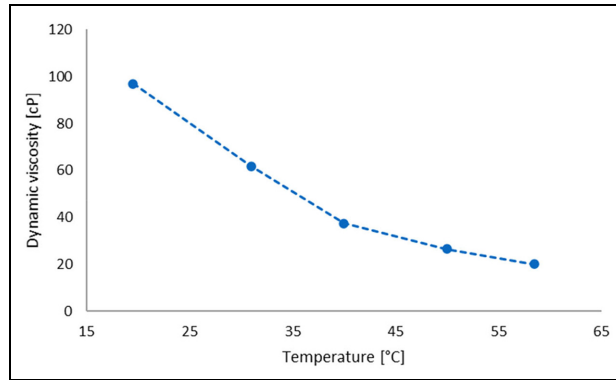
**Figure 9.** Measured dynamic viscosity of Titan Sintofluid FE SAE 75 W at different temperatures.

in the actual transmission of the test vehicle (simulated with the developed test-rig). The lubricant dynamic viscosity variation with temperature is shown in Figure 9. For this purpose, a U-tube viscometer was employed. To measure viscosity at different temperatures the U-tube viscometer was submerged into the tank of fluid containing an electrical heating element. After the tank temperature reaches a prescribed steady-state level, the time taken for the lubricant to flow within the U-tube viscometer between two fixed points is measured. This procedure was repeated five times at each temperature and the average value were noted. The kinematic viscosity of the lubricant was obtained based on multiplying the time taken in seconds to the viscometer constant. To measure the density of the lubricant at each temperature, the heated lubricant was poured into a 15 cm<sup>3</sup> volumetric flask and its mass was measured.
